# The Impact of Pollution on Cultural Heritage in the Historic Centre of Porto, Portugal

Fátima Matos Silva, Marta Arreiol and Ana Fragata

<https://doi.org/10.3390/urbansci8020031>

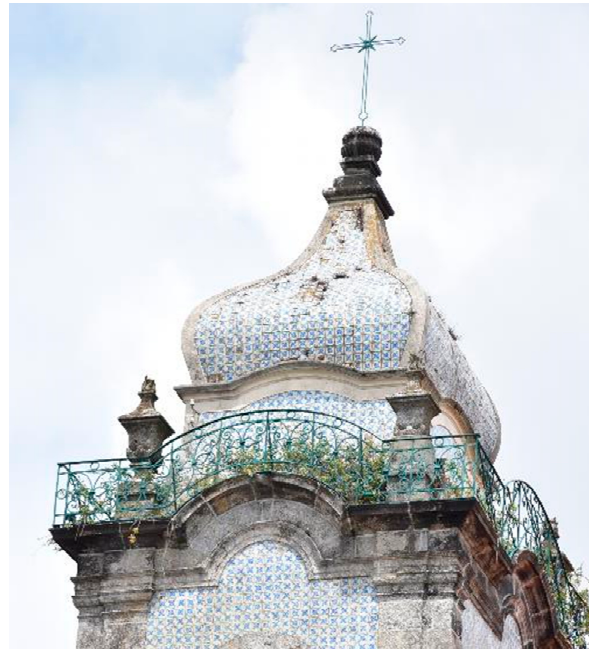
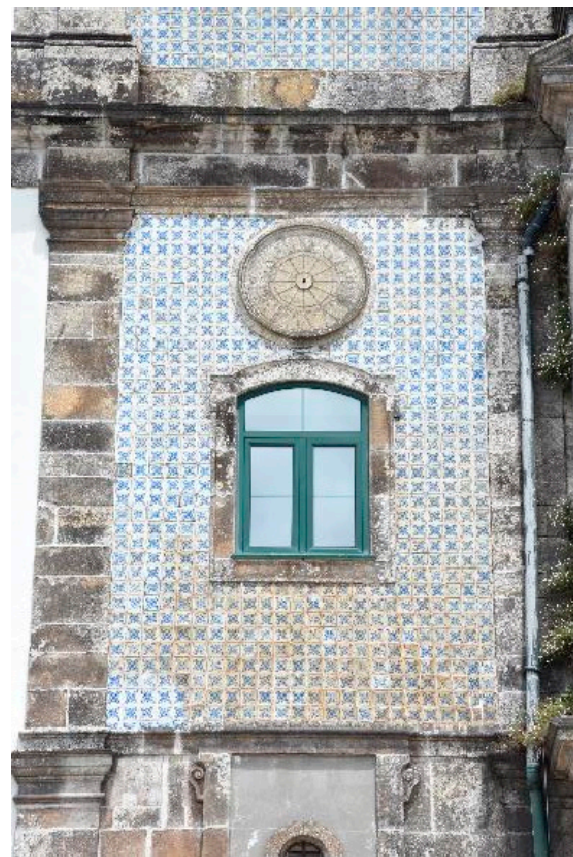
**Figure 15.** Details of the anomalies present on the south facade of Carmelitas Church. Source: author.

**Figure 16.** Details of the anomalies present on the south facade of Carmelitas Church. Source: author.

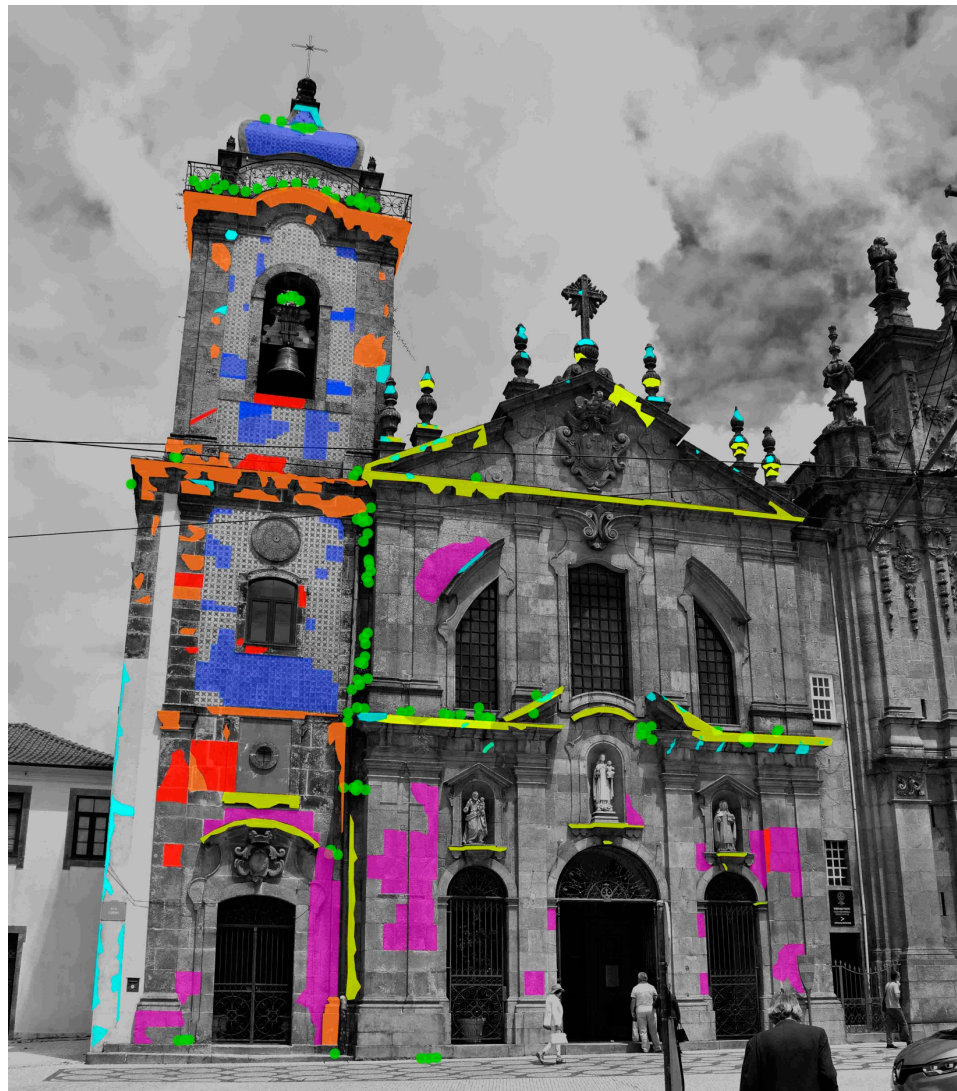
The anomalies mapping (Figure 17 and Table 3) revealed the existence of dirt and black crusts on the main facade, the presence of vegetation (with a greater incidence in the bell tower), humidity, cracking, and detachment of the glaze on the tiles, and, finally, chromatic changes, scaling, granular disintegration, and biological colonisation in stone masonry.

**Figure 17.** Anomalies map of the front facade of Carmelite Church. Source: Author.

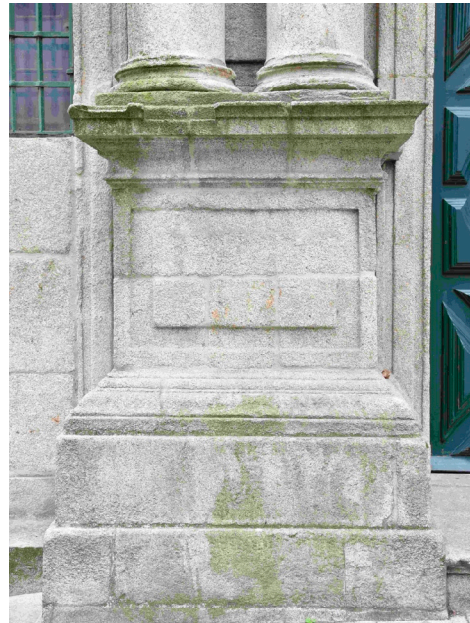
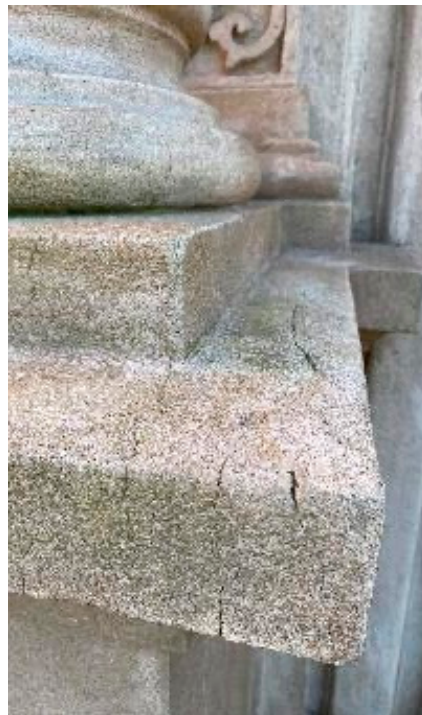
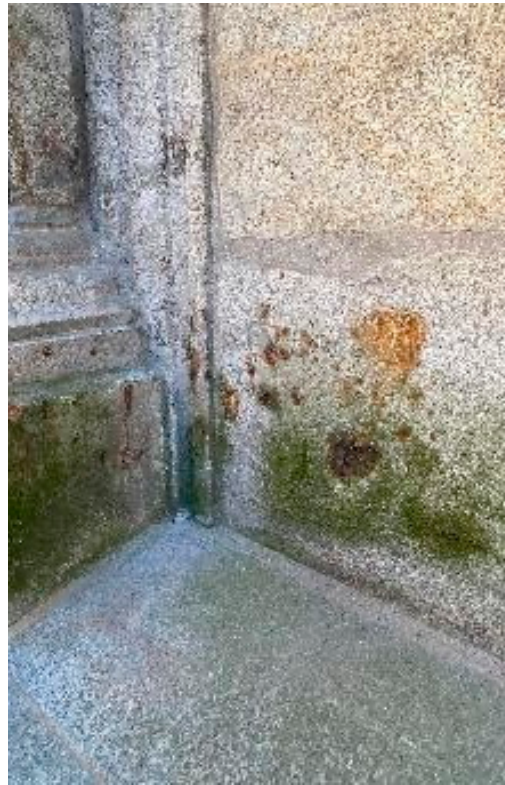
After completing all the photographic documentation (Figures 20–22) and creating the degradation map (Figure 23 and Table 4), we highlight the main pathologies on the main facade of São João Novo Church: biological colonisation, cracks, and humidity, with a higher incidence on the pediments and columns, as well as some lacunae across the entire facade, open joints, and vegetation, with greater predominance in the upper part of the building.

**Figure 20.** Identification of the various pathologies on the north facade of São João Novo Church. Source: Author.

**Figure 21.** Identification of the various pathologies on the north facade of São João Novo Church. Source: Author.

**Figure 22.** Identification of the various pathologies on the north facade of São João Novo Church. Source: Author.

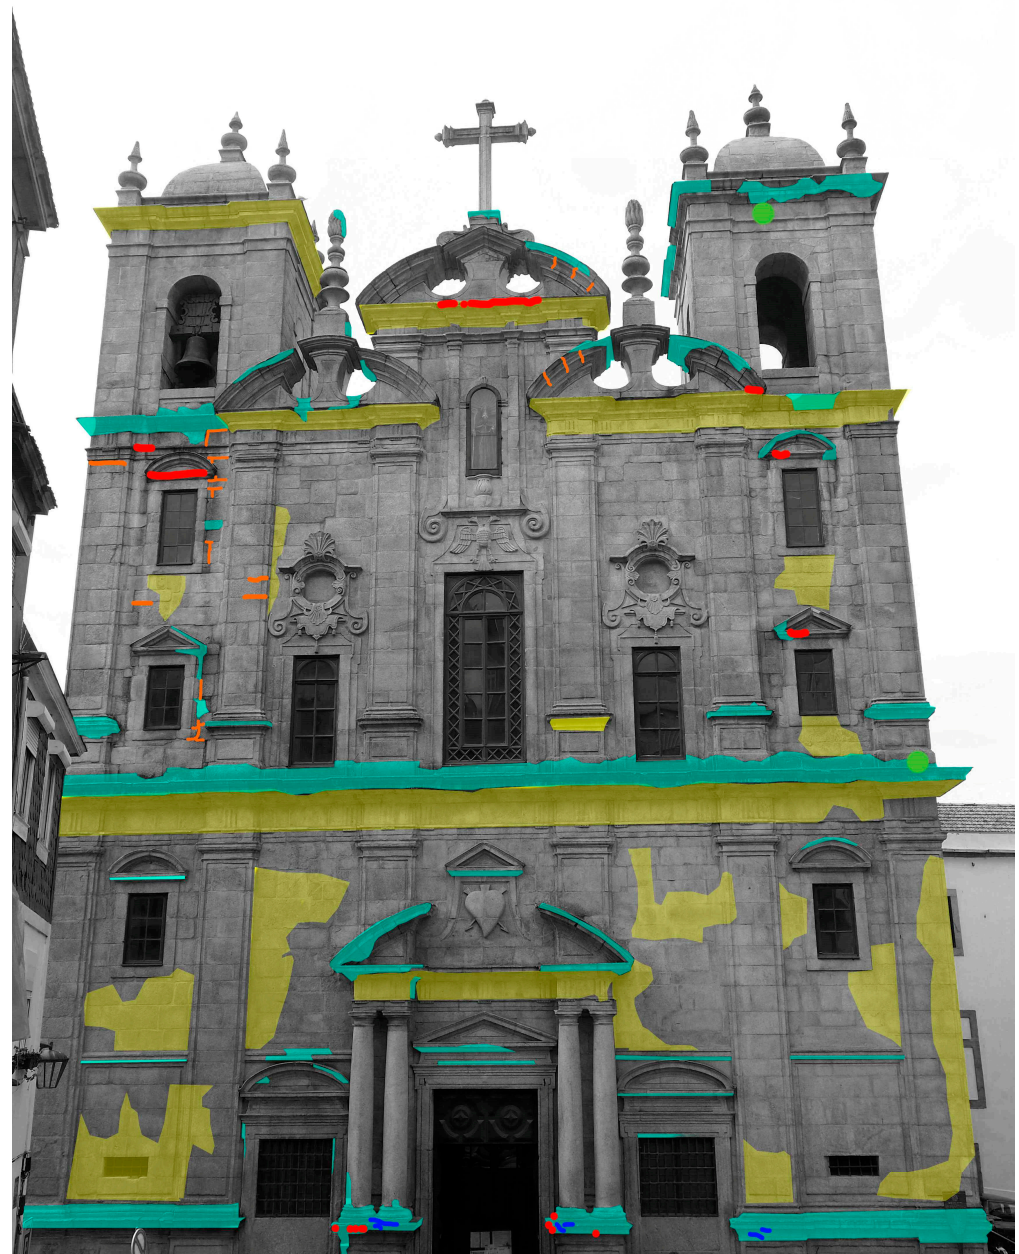
**Figure 23.** Anomalies map on the front facade of Carmelite Church. Source: Author.

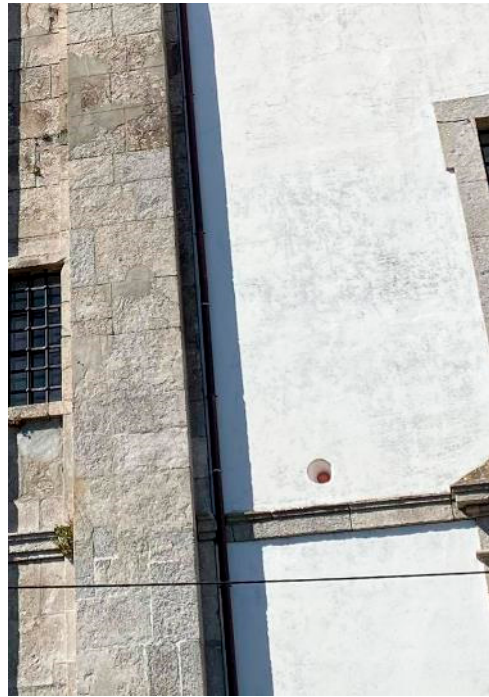
**Figure 25.** Bullet inlay in the south wall. Source: Author.

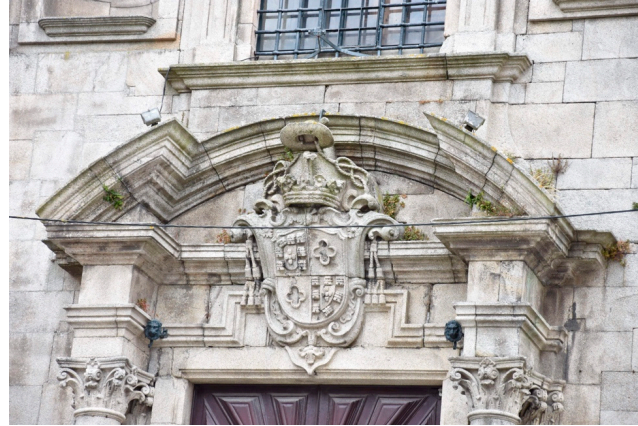
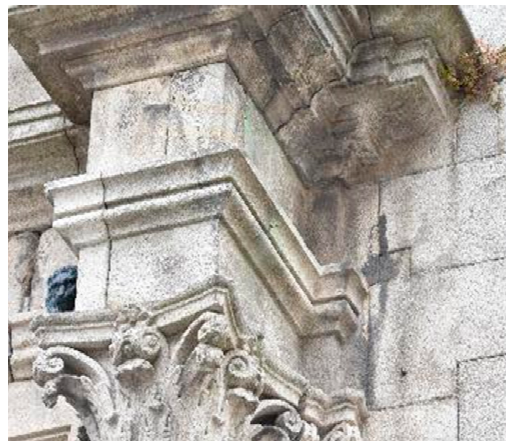
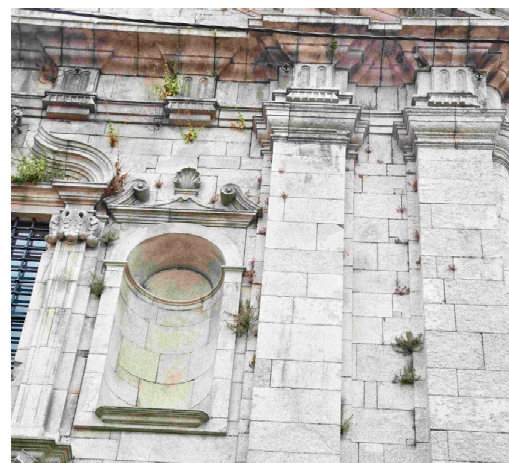
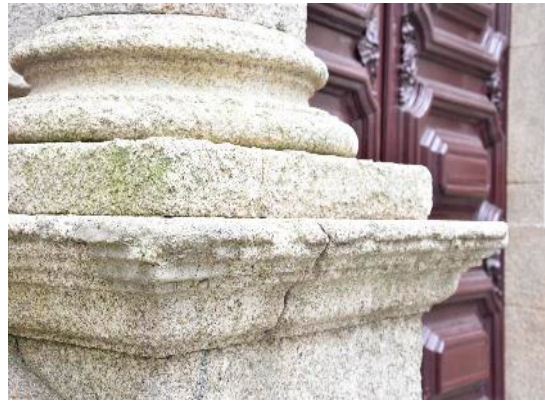
After detailed analysis (Figures 27–30) and mapping of anomalies (Figure 31 and Table 5), the main anomalies identified on the main façade of Vitória Church were vegetation, biological colonisation, gaps, black crusts, dampness, cracks, and platelets.

**Figure 27.** Identification of the various pathologies on the north façade of Vitória Church, Porto.  
Source: Author.

**Figure 28.** Identification of the various pathologies on the north façade of Vitória Church, Porto.  
Source: Author.

**Figure 29.** Identification of the various pathologies on the north façade of Vitória Church, Porto.  
Source: Author.

**Figure 30.** Identification of the various pathologies on the north façade of Vitória Church, Porto.  
Source: Author.

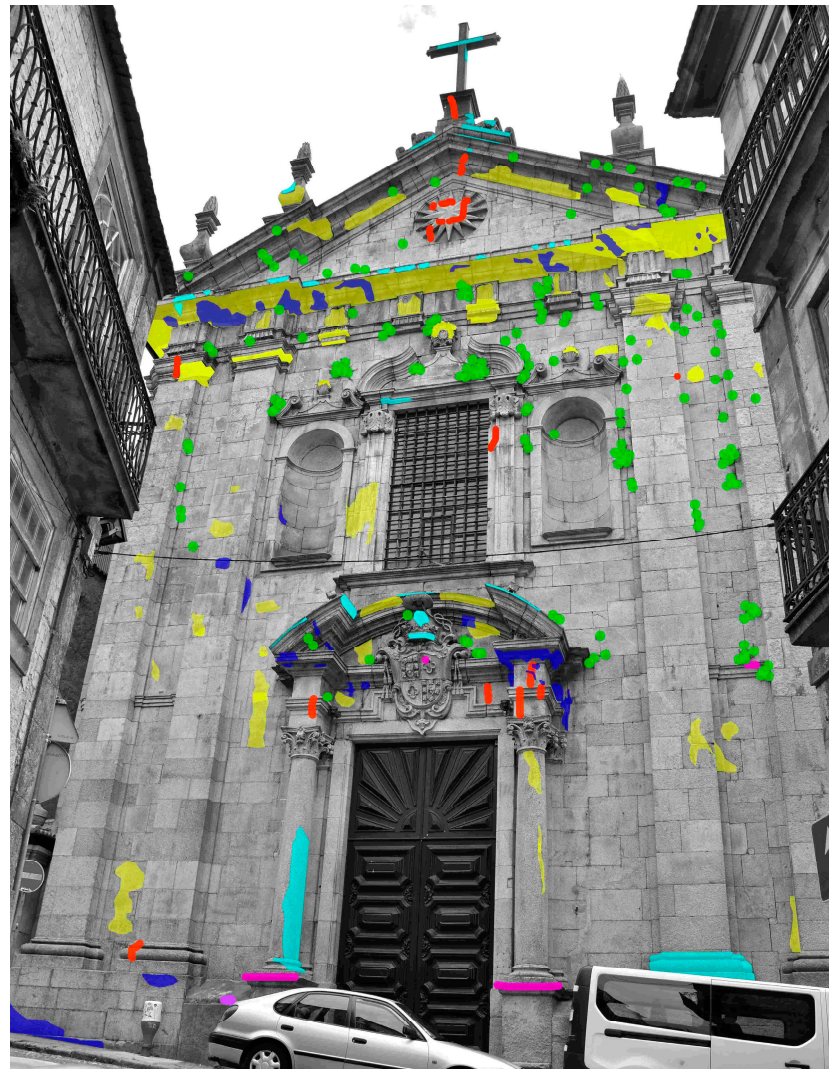
**Figure 31.** Anomalies map on the front facade of Vitória Church. Source: Author.
