**REPORT ON THE JOINT WORLD HERITAGE CENTRE / ICOMOS / ICCROM
REACTIVE MONITORING MISSION TO
FORTS AND CASTLES, VOLTA, GREATER ACCRA, CENTRAL AND WESTERN REGIONS
(GHANA)**

1 to 11 February 2020

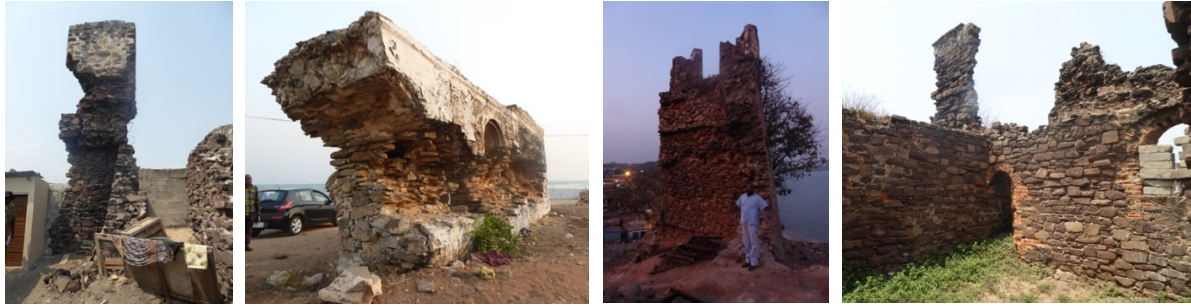
Figs. 1 to 4 – Structural instability of some of the walls in Fort Vredenburgh (Fig.1), Fort Fredensborg (Fig.2), Fort Nassau (Fig.3), and English Fort (Fig.4)

The instability of the remains in these forts and very fragile walls threaten the community that lives nearby, and especially the children that play close to the walls. As a prompt and proactive response to save lives, support posts should be installed to secure vulnerable walls and to address preventive action.

There is a need for urgent structural measures to address the consolidation of several forts' unstable walls, which can fall at any time. This is the case, for instance, at:

- a) Fort Vredenburg, in Dutch Komenda;
- b) Fort Fredensborg in Old Ningo;
- c) Fort Nassau in Mouri;
- d) English Fort, in British Komenda.

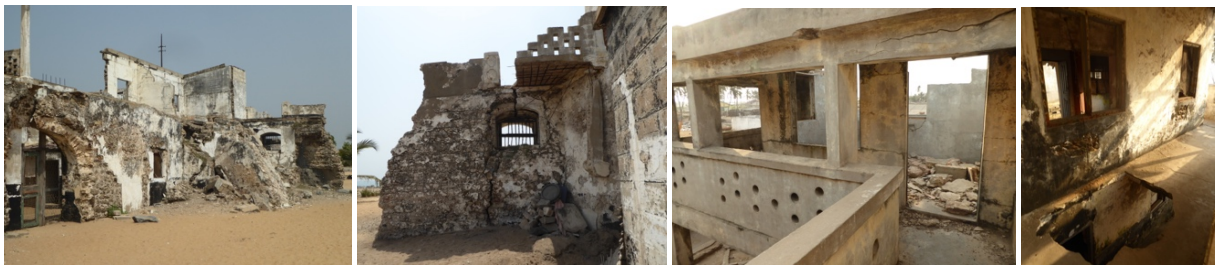
Figs. 5 to 8 – Structural instability in Fort Prinzenstein (Figs.5 & 6) and Fort Vernon (figs.7 & 8)

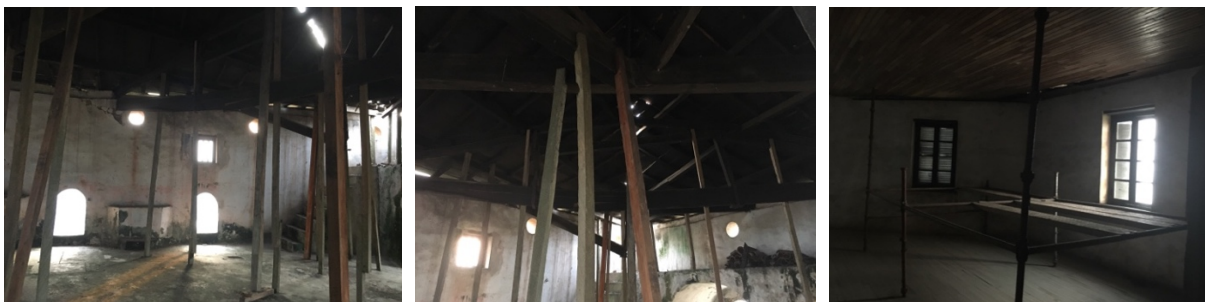
Figs.9 to 11 – The roof wooden structure is falling in the northwest and the ceiling in the northeast of Fort St. Jago, in Elmina.

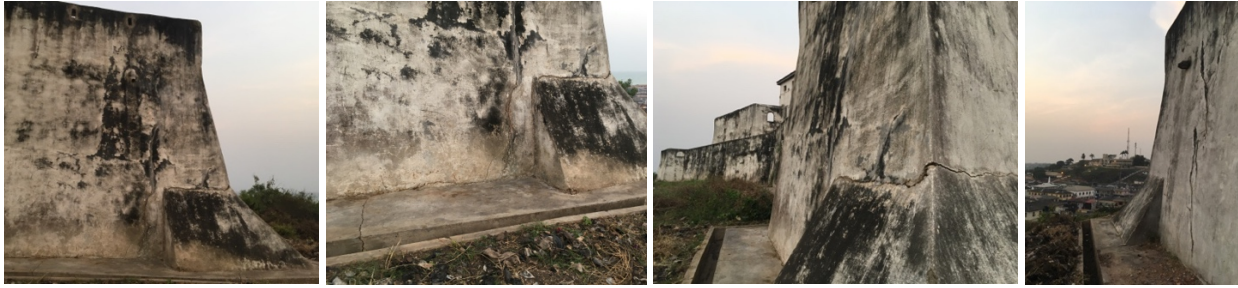
Figs. 12 to 15 – In St. Jago Fort, the northwest bastion is sinking due to unstable ground.

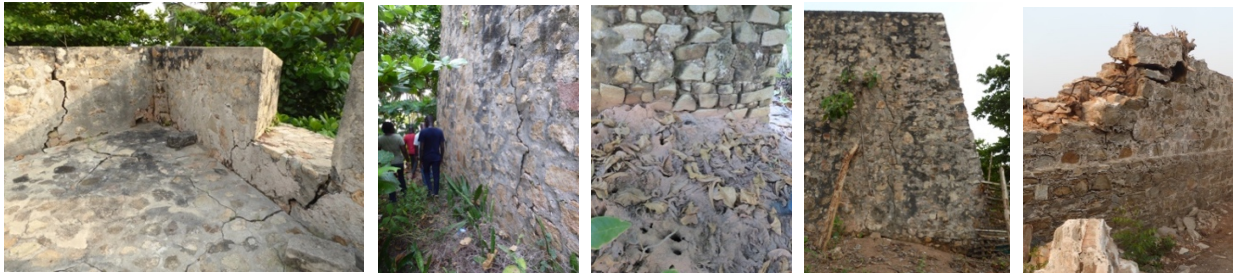
Figs. 16 to 19 – In Fort Groot Fredericksborg, the southeast bastion (figs.16-18) and the southwest bastion (fig.19) are sinking.

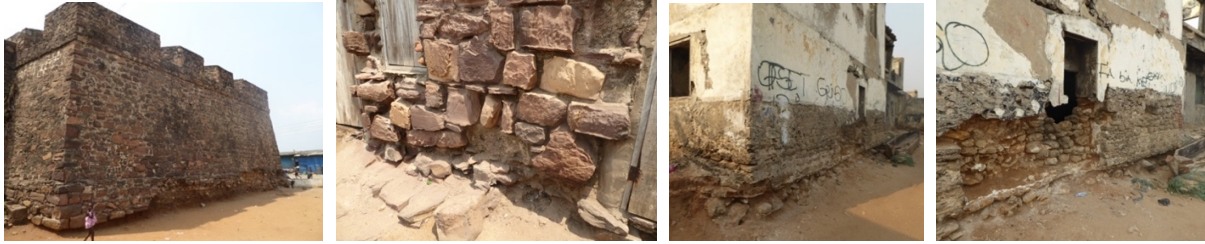
Figs. 21 & 22 – Sea erosion, removal of stones and exposed foundations are visible in English Fort (British Komenda).
 Figs. 23 & 24 – Erosion of the wall base and exposed foundations are also visible in Fort Vernon in Prampram.

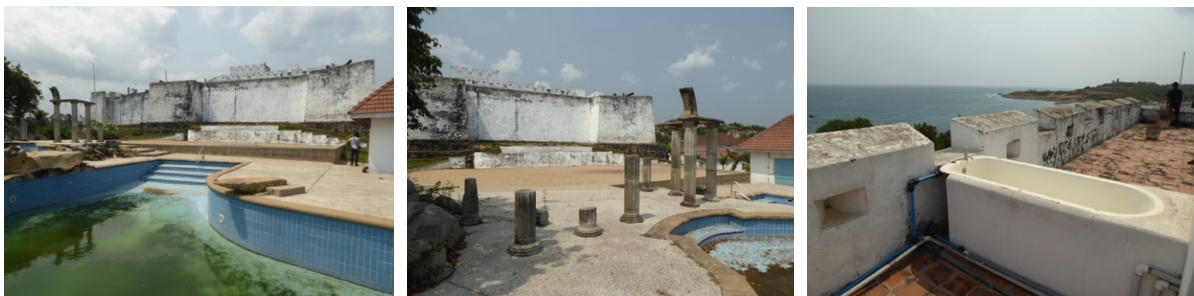
Figs. 25 to 27 – A swimming pool, roman style cement columns, and a bath tube were built in and around Metal Cross Fort.

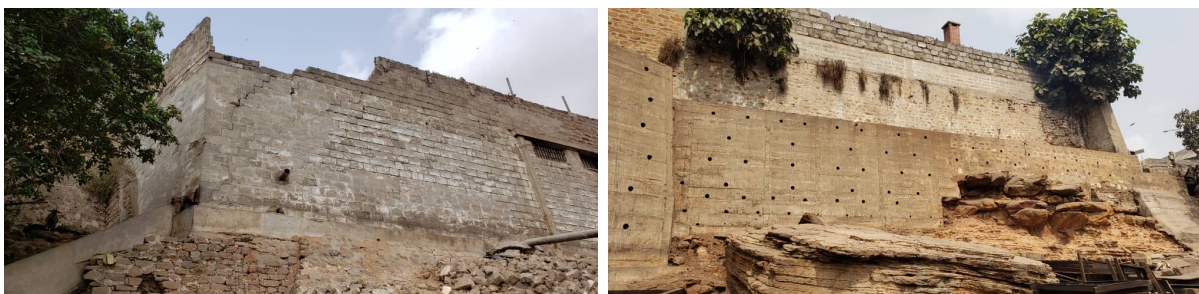
Figs. 28 & 29 – Cement bricks were added to the walls of Fort James.

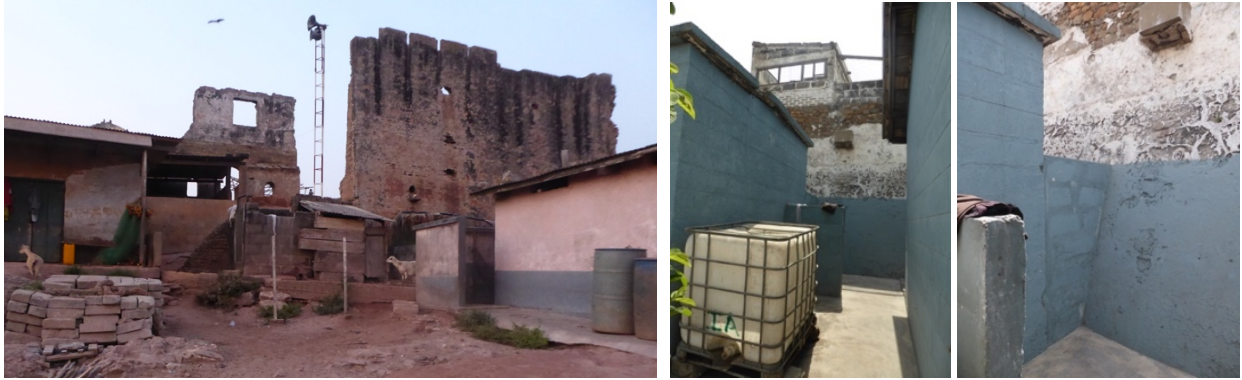
Figs. 30 to 32 – Illegal construction was built around Fort Nassau (fig.30), and Fort Prinzenstein (figs.31 & 32).

There is some illegal construction in the north side of the fort (see figs. 31 and 32). When the fort was being used as a prison, some structures were built to house prison guards. There is an opportunity to delineate a proper core boundary and an effective buffer zone. GMMB should delineate the component's boundaries as a matter of priority. There are serious structural challenges that need to be addressed through urgent consolidation and repairs (as mentioned in subchapter 4.2.1. and also observed in figs. 5, 6, and 42). The local community led by the local chief takes care of the fort and addresses minimum maintenance and cleaning of the fort. GMMB provided some guidance to the community for the maintenance work.

All the new parts that were previously mentioned were added to James Fort, Ussher Fort, Fort Prinzenstein, Fort Nassau, Fort William, St. George Castle in Elmina, English Fort (British Komenda), Fort Vredenburg (Dutch Komenda), Fort Orange, and Fort Apollonia. These additions should be removed to the extent possible, without endangering the original elements.

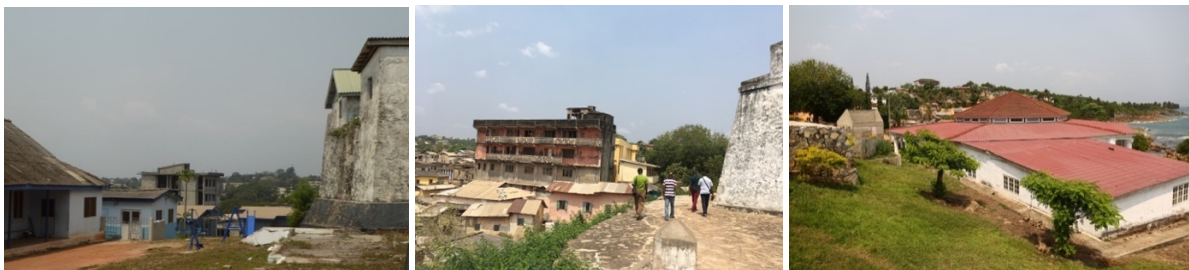
Figs. 33 to 35 - Urban pressure is increasing around Fort Orange (fig. 33) and around Fort Metal Cross (figs. 34 & 35), through high-rise buildings and new concrete houses (fig. 34), and a new open-air restaurant (fig. 35).

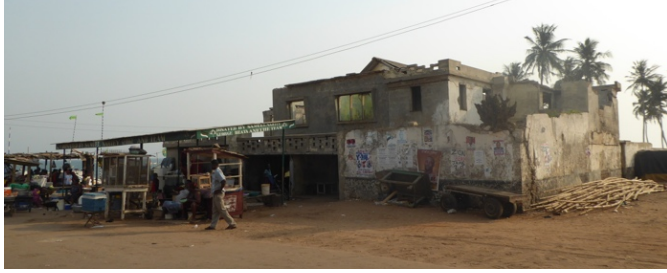
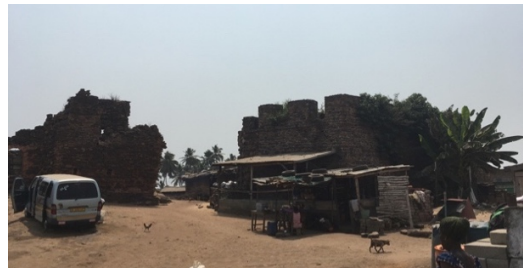
Figs. 36 & 37 – Encroachment in Fort Vernon and in English Fort (British Komenda)

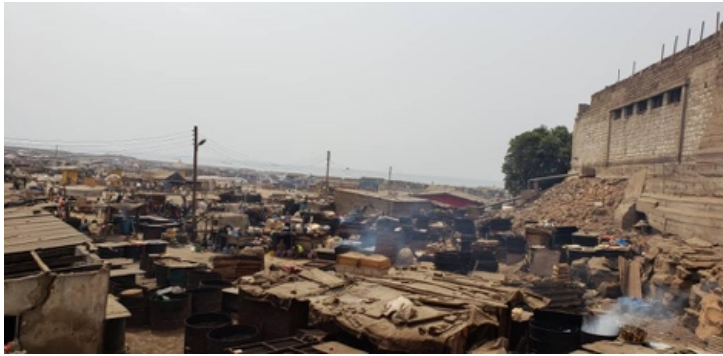
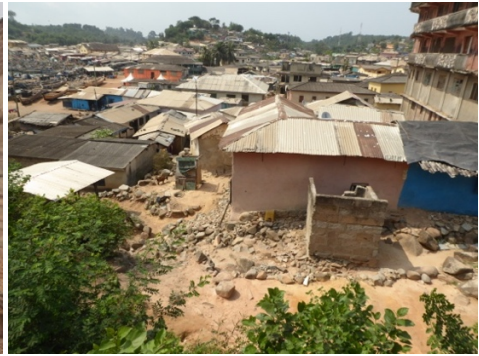
Encroachment was detected in several World Heritage components. In some cases, it was about shelters built for daily selling of food (figs.36 & 37); in other cases it was detected that areas around the components were used for storage (fig.38), or for shelters firstly built with non-lasting materials (as wood and metal sheeting), and then, through time were replaced by cement blocks or concrete houses. These intrusions were built too close to the listed forts and castles. This was the case, for instance, in Fort Vernon (fig. 36), in English Fort (English Komenda) (fig. 37), in Fort Vredenburg (Dutch Komenda), in Fort Amsterdam, in Fort Ussher, in James Fort (fig.38), among several others. The State Party will not be able to prevent encroachment effectively until they clearly define and make known the boundaries and the buffer zones of the property.

Figs. 38 & 39 – Human pressure brought by daily encroachment, in James Fort, and around Fort Metal Cross.

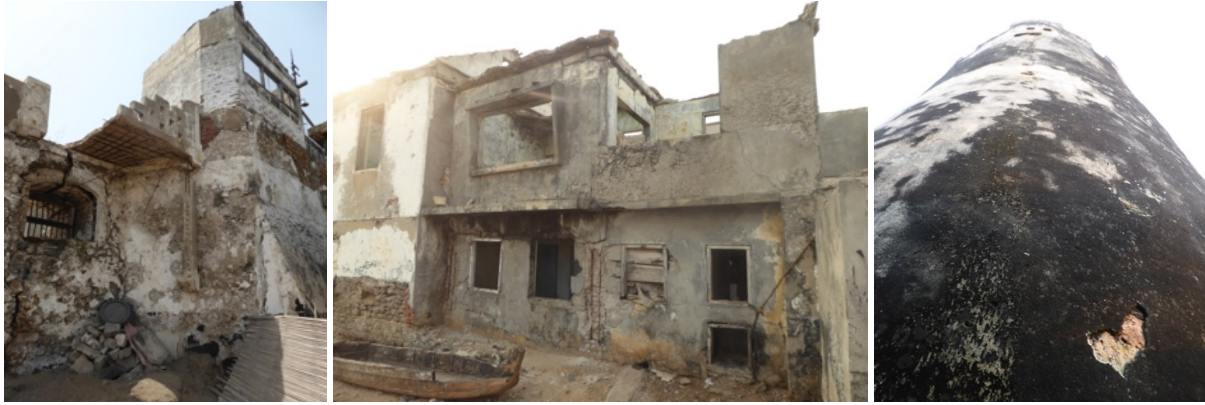
Figs. 42 – Several new additions with modern materials were addressed in Fort Prinzenstein.

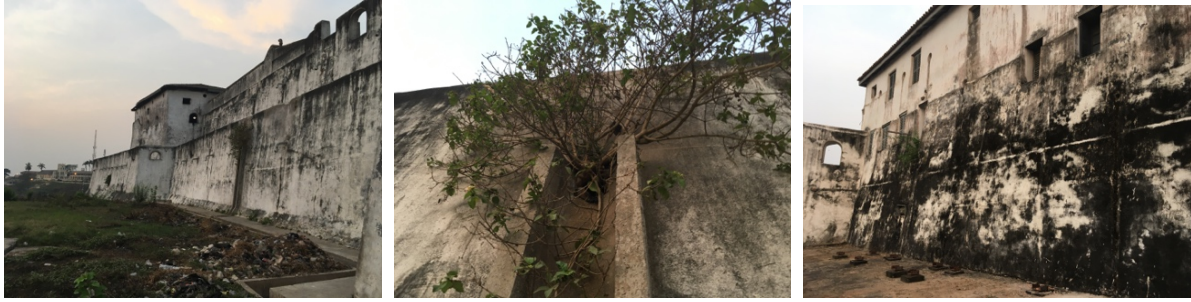
Figs. 47 to 49 – Neglect on clearing out gutters; and lack of wall cleaning and wall lime wash at St. Jago Fort walls

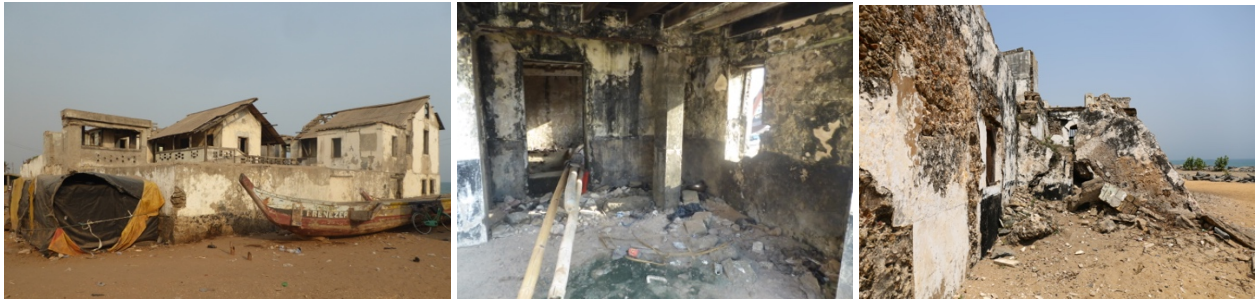
- a) Fort Prinzenstein in Keta. In spite of the caretaker's effort, the lack of maintenance resulted in a strong degradation and even neglect of the ruins following the fact that two thirds of the component were washed away by the sea (see fig. 52).

- c) Fort Vernon in Prampram. The fort is totally abandoned (as observed in figs. 50 & 51), and some rooms are even used as public toilets.
- d) Fort Victoria located in the middle of bushes with difficult access.

Fig. 50 to 52 – Total neglect and abandonment of Fort Vernon (figs. 50 & 51) and neglect of the ruins of Fort Prinzenstein (fig.52).

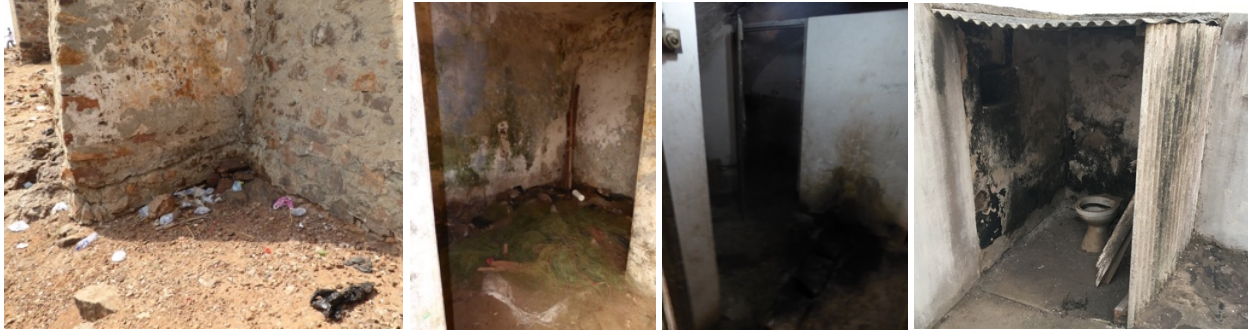
Fig. 53 to 56 – Fort exterior corners used as public toilet in Fort Good Hope (fig.53); interior space used as toilet in Fort Vernon (fig.54); existing toilets that are not working in Fort William (lighthouse) (fig.55); and open toilets in St. Jago in Elmina (fig.56).

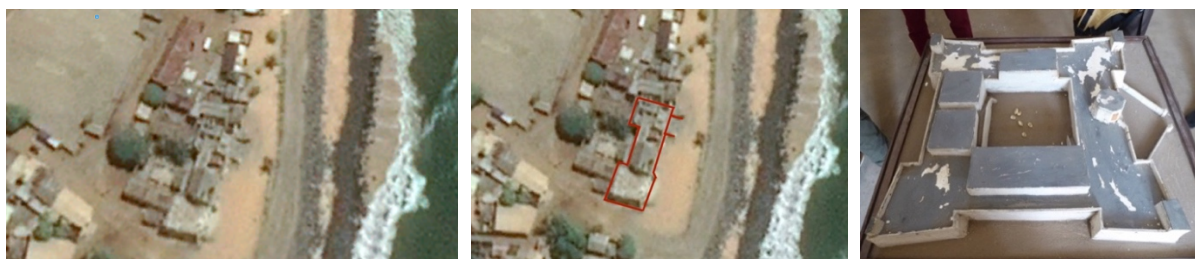
Figs. 57 to 59 – Google view of Fort Prinzenstein (fig.57); existing limits of the fort (fig.58); model of the original fort (fig.59).

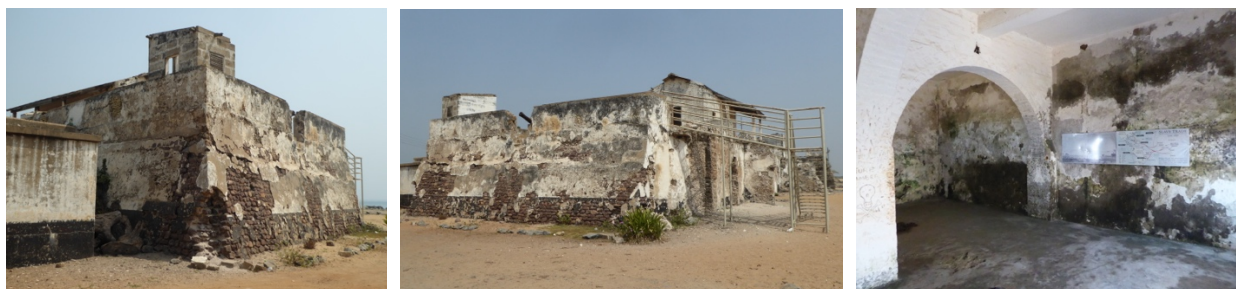
Figs. 60 to 62 – Southwest view of Fort Prinzenstein (fig.60); south view of the fort with visible part missing (fig.61); and new arch against ancient wall with interpretation panels for visitor's information (fig.62).

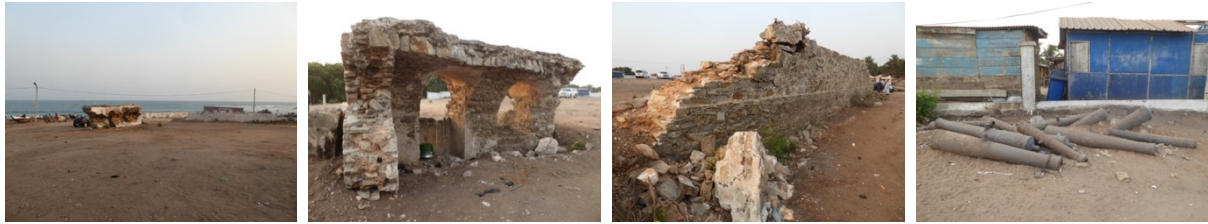
Figs. 66 to 69 – The only remains left from Fort Fredensborg, in Old Ningo.

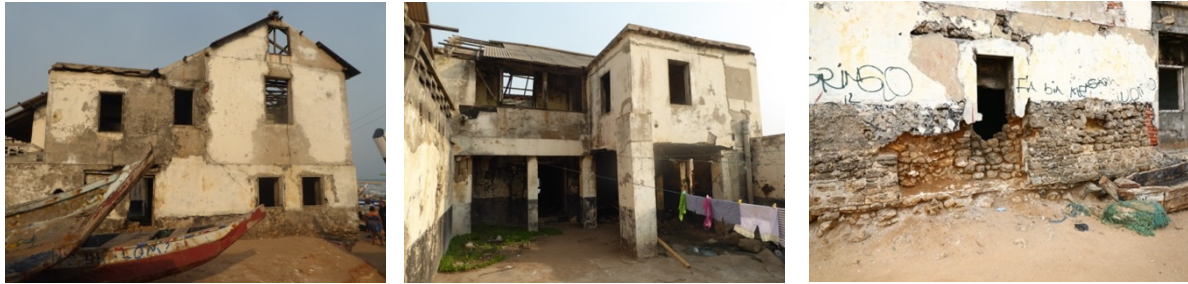
Figs. 70 to 72 – In Fort Vernon, cement additions from previous years, were followed by prominent neglect (figs.70 & 71). Decayed foundations of Fort Vernon (fig.72).

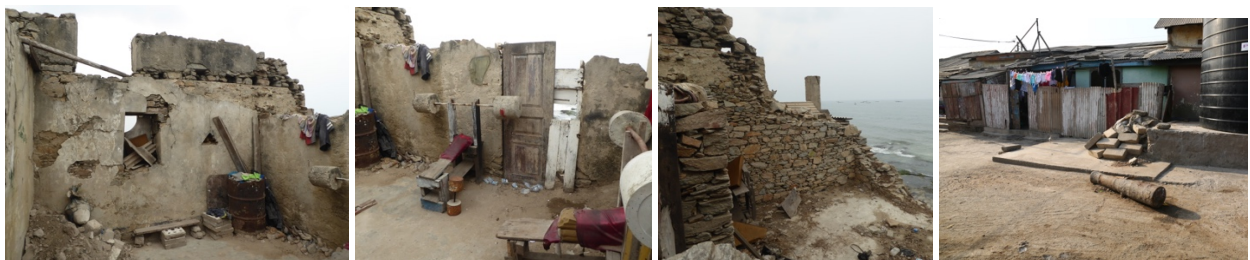
This component does not have a formal boundary and buffer zone. The bits of walls shown to the Mission Team, as traces of the fort, are now fully incorporated into people's houses (see figs. 70 to 72). The GMMB is also not fully certain of the exact site of Fort Augustaborg, as another open space was presented to the Mission Team, a few hundred meters away from the first visited wall traces. GMMB suspects that this second location, used today for communal gatherings and as a parking lot, might also be the former location of Fort Augustaborg, due to its designation by some people of the local community as "the place of the old building", some suspected traces of foundations, and the fact that old cannons are still there (see fig.73).

Figs. 73 to 76 – Traces from Fort Augustaborg (first possibility – figs.73 to 75, and second possibility – fig.76).

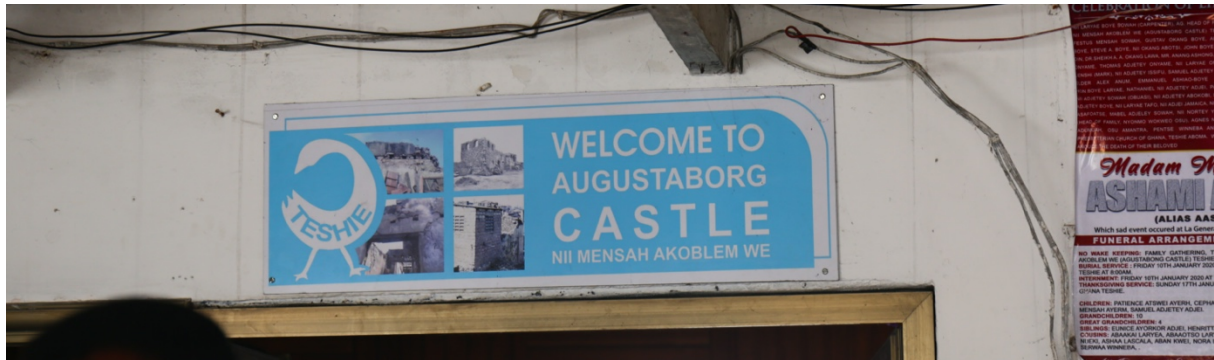
It must be noted that the residents now living at Augustaborg are aware of the place to be some sort of a heritage site and eager to receive visitors, but they were not aware of it being a component of a World Heritage property and also do not have formal ties with the GMMB. A sign above the access to the area with the wall traces welcomes visitors and shows old photographs of the fort, already in ruins.

Fig. 77 – Sign welcoming what is believed to be the entrance of Fort Augustaborg

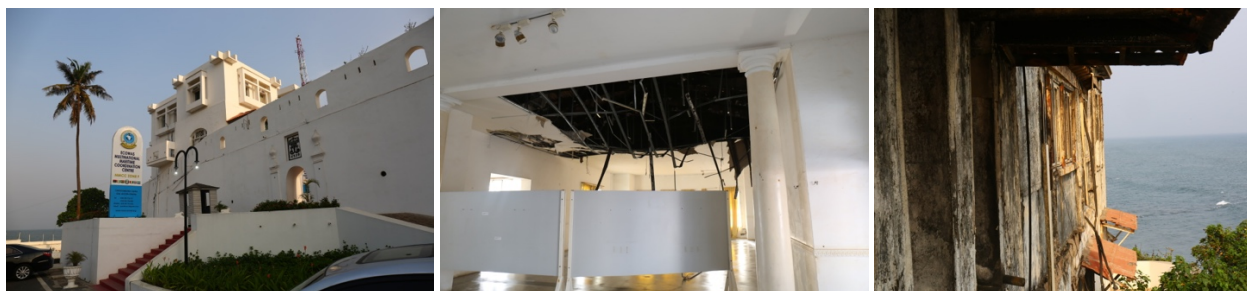
Figs. 78 to 80 – Christiansborg Castle, in Osu has the front façade well kept, but the inside and the rear façades need intervention. In fig. 78, it is also well observed the signpost at the front of the Fort, not related with the site’s interpretation.

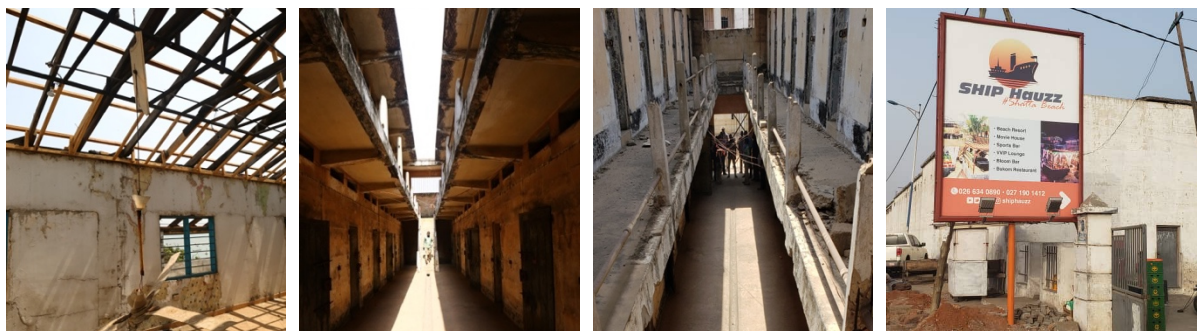
Figs. 81 to 84 – Ussher Fort, in Usshertown is highly deteriorated and needs urgent intervention (figs.81 to 83). A wide signpost, at the entrance of the fort, doing publicity to a Beach Resort, also interferes with the site interpretation (fig.84).

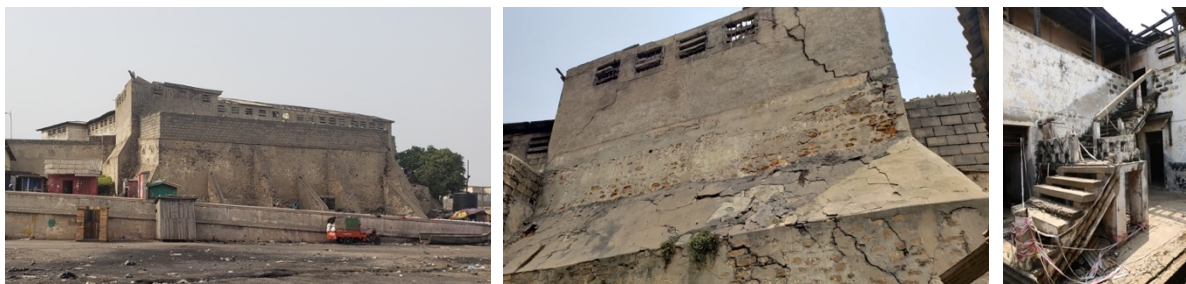
Figs. 85 to 87 – Fort James, in Jamestown is highly deteriorated, and damage can be already observed.

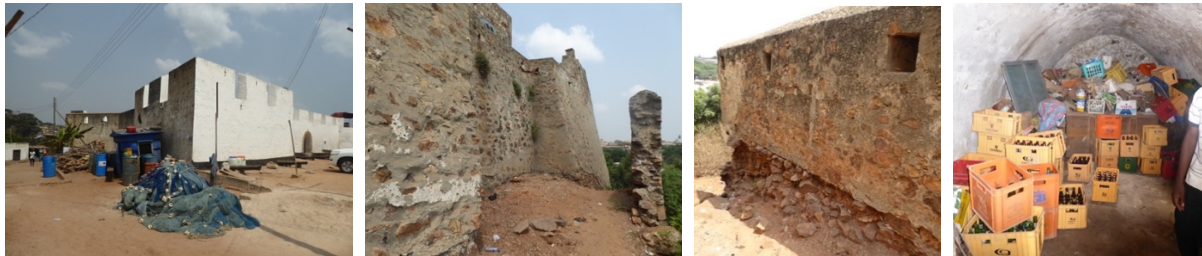
Figs. 88 to 91 – Encroachment (fig.88), cement plaster (fig.89), wall erosion (fig.90) and ancient dudgeons being used as storage (fig.91), can be observed in Fort Good Hope, in Senya Beraku.

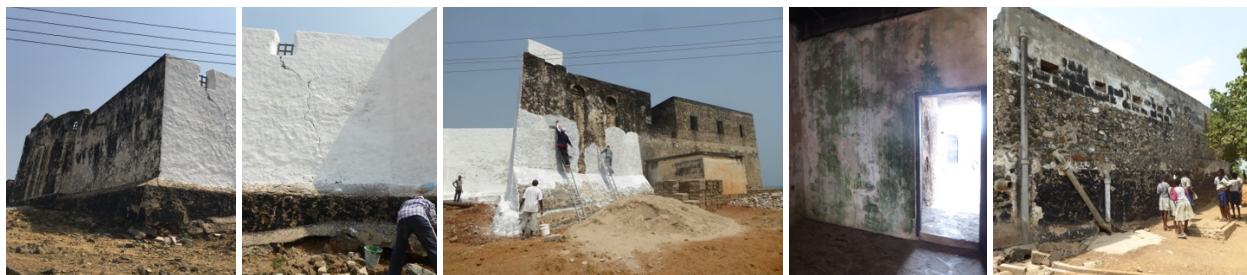
Figs. 92 to 96 – Lime wash at Fort Patience is hiding fungus on the walls and structural issues that need to be addressed.

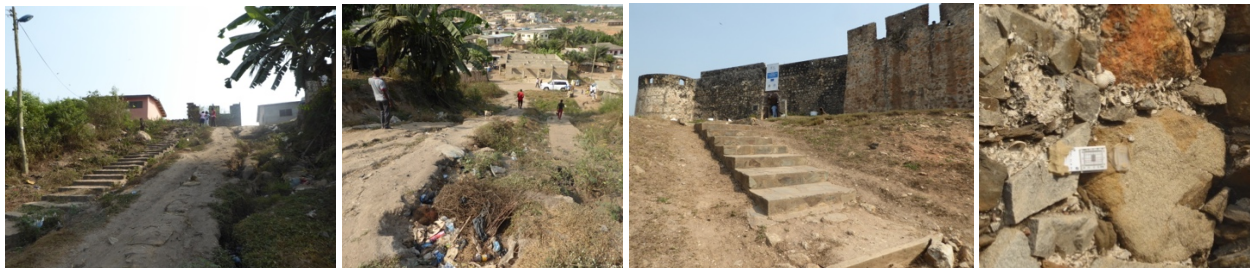
Figs. 97 & 100 – Access to Fort Amsterdam in Abandze (figs.97, 98 & 99), and a crack monitor device to measure fissures (fig.100).

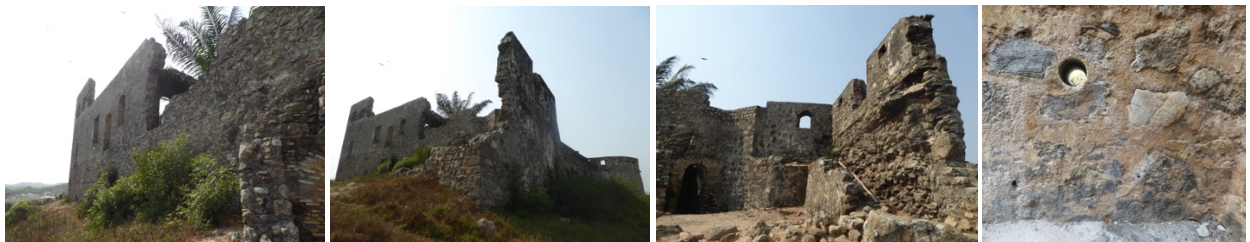
Figs. 101 to 104 – Need for structural consolidation in Fort Amsterdam (figs. 101 & 102), wall erosion (fig. 103) and a hole left by a drill when extracting soil for analysis (fig.104).

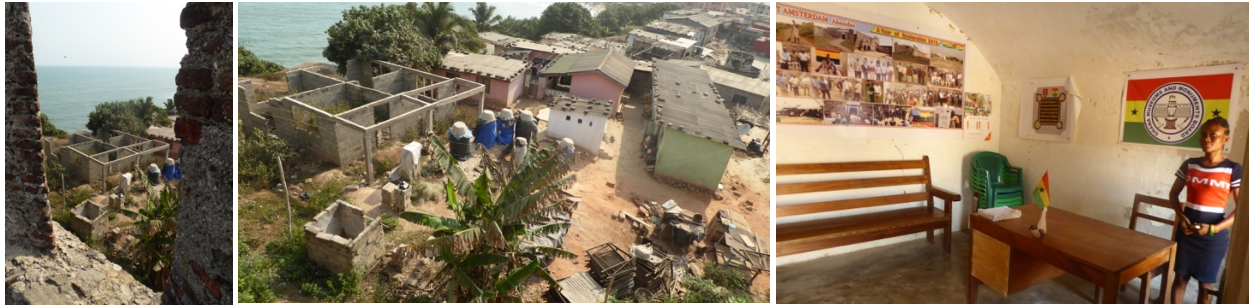
Figs. 105 to 107 – Encroachment and urban pressure continues to grow near the fort. Visitor centre in one of the fort rooms.

Assessment of the component’s contribution to the property’s Outstanding Universal Value: The authenticity and integrity of this component remain present and not facing an immediate threat. There is a tourist room for visitors to rest and to buy local handicrafts (see fig. 107). The physical fabric which is directly associated with the intangible attributes is in place. The sense of place and emotive feeling that the component carries should be brought out through improved site presentation and interpretation, in order to enhance the intrinsic attributes. The values of the property’s OUV are supported by this component.

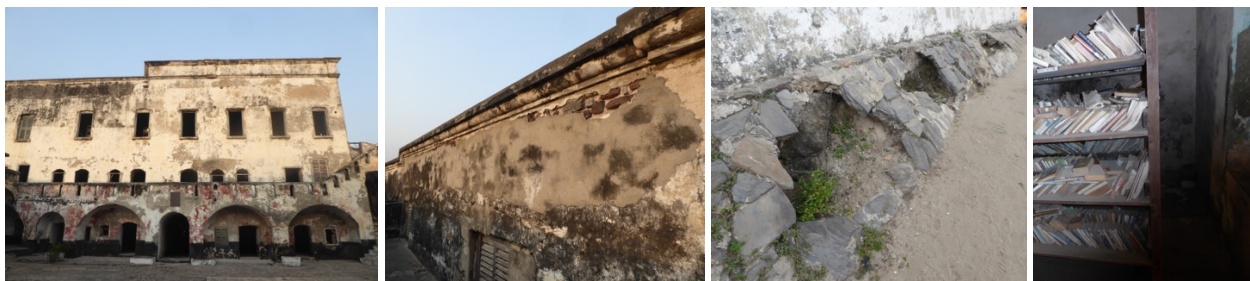
Figs. 108 to 111 – Interior terrace at Fort William (fig.108), inadequate cement plasters (fig.109), impact of the sea erosion in the East side of the building (fig.110), and abandoned library at the fort (fig.111).

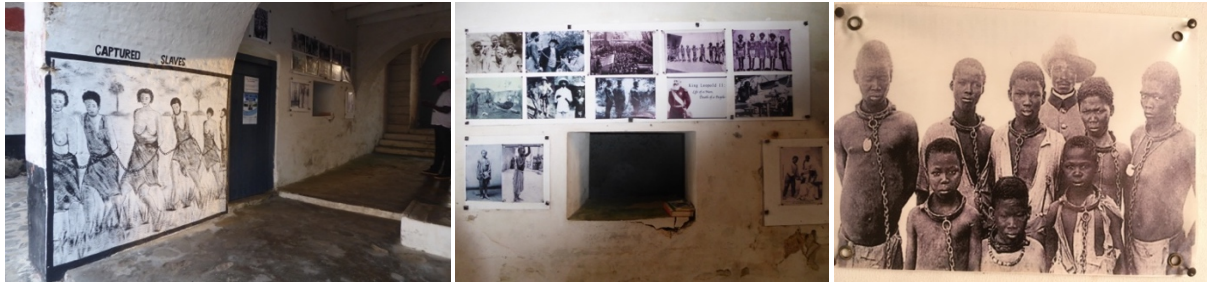
Fort William was in several respects a positive surprise to the Mission Team, as the caretaker is personally engaging considerably in ensuring that the site attracts tourists. With hardly any financial means at his disposal, he has developed a small exhibition in the entrance space of the Fort, displaying photographs related to the slave trade and containing conciliatory messages for visitors, especially to the African diaspora. The fort is also operating a small gift shop, and according to GMMB there are two shrines located in the dungeons. In addition to these efforts, the caretaker has also created a Facebook page dedicated to the presentation of the fort and he developed a small promotional leaflet.

Figs. 112 to 114 – Paintings and photos hung by Fort William caretaker. They bring a very strong emotional bond to the site.

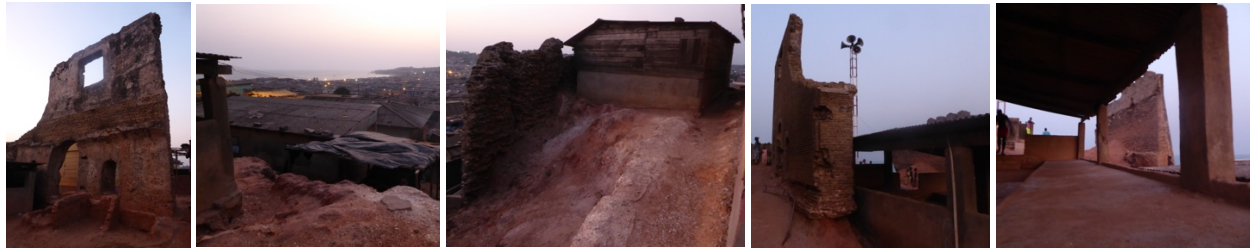
Figs. 115 to 119 – View of the remain walls still standing in Fort Nassau (fig.115), urban pressure (fig.116), encroachment (fig.117), and a new concrete religious building that was erected touching the last remains of the fort archaeological walls (figs.118 & 119).

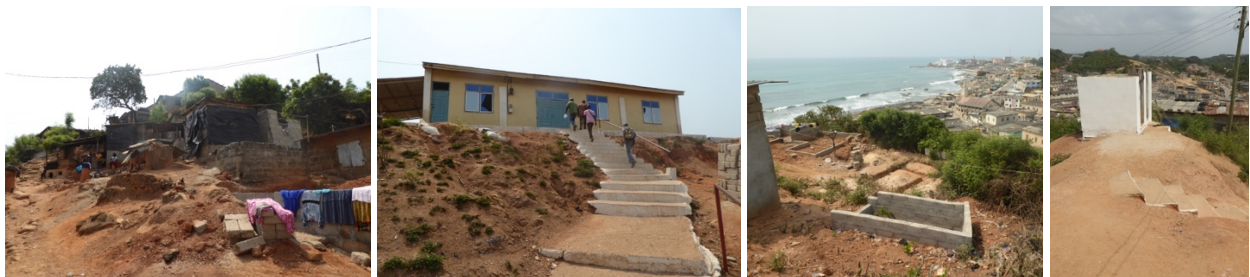
Figs. 120 to 123 – Fort Fredricksborg location: difficult access to the site (fig.120); new building in the supposed site location (fig.121); urban pressure and construction being developed at the site (fig.122); public toilets at the site (fig.123).

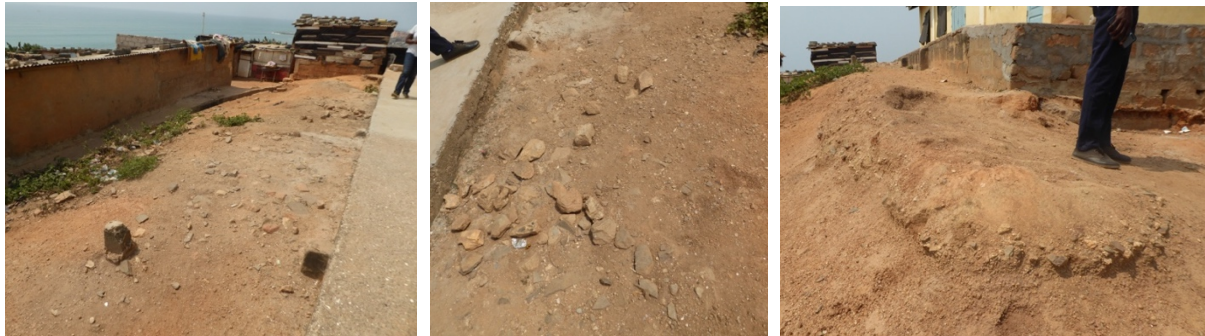
Although historic sources indicate that Fort Fredricksborg was used by the Danish as their headquarters for a short period before being taken by the British who called it Fort Royal (Van Dantzig,

1980), there is strictly no visible trace left and it is obvious and evident that, in the absence of any attributes, site interpretation is impossible.

Figs. 124 to 126 – No remains were observed that could indicate the existence of Fort Fredricksborg at that location.

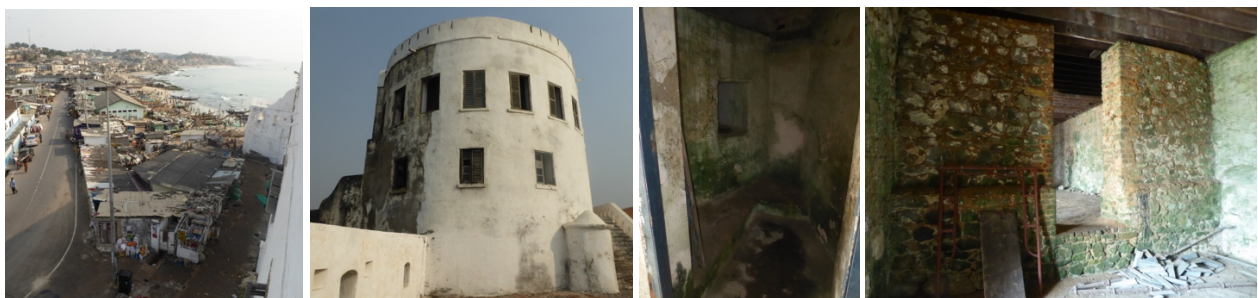
Figs. 127 to 130 – Encroachment near Cape Coast Castle (fig.127); occasional use of plastic paint instead of lime wash (fig.128); and interior rooms deterioration due to growing mould fungus originated from high moisture (figs.129 & 130). Historical dudgeons, where slaves were kept, should not be restored or limewashed. They should only be conserved, to avoid further deterioration.

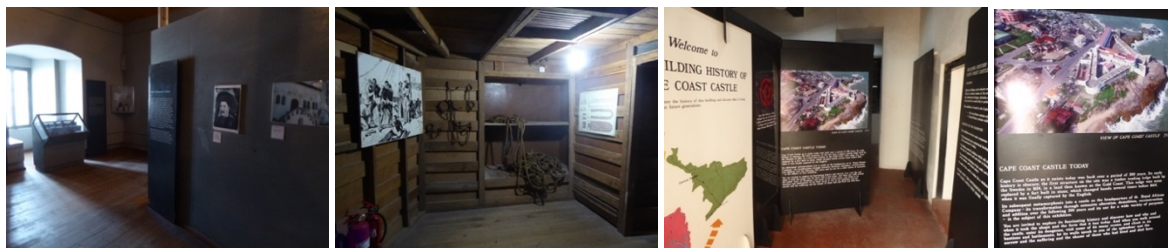
Figs. 131 to 134 – Photos, paintings, documents and ship recreation to present castles and forts interpretation.

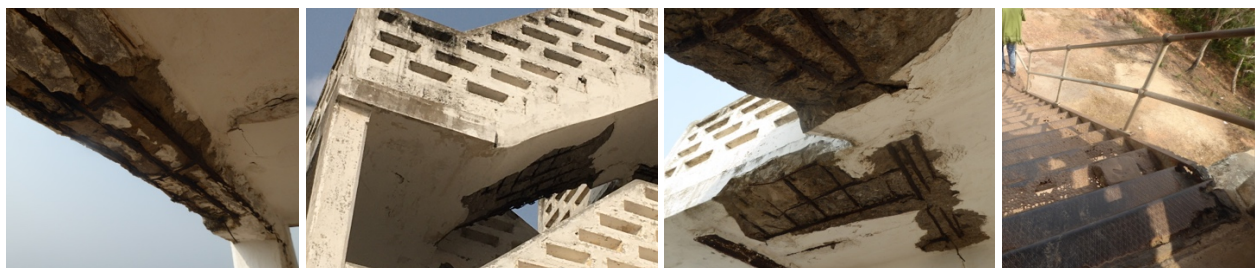
Figs. 135 to 138 – Concrete deterioration due to steel corrosion (figs.132 to 134). Corrosion of the metal stairs (fig.135).

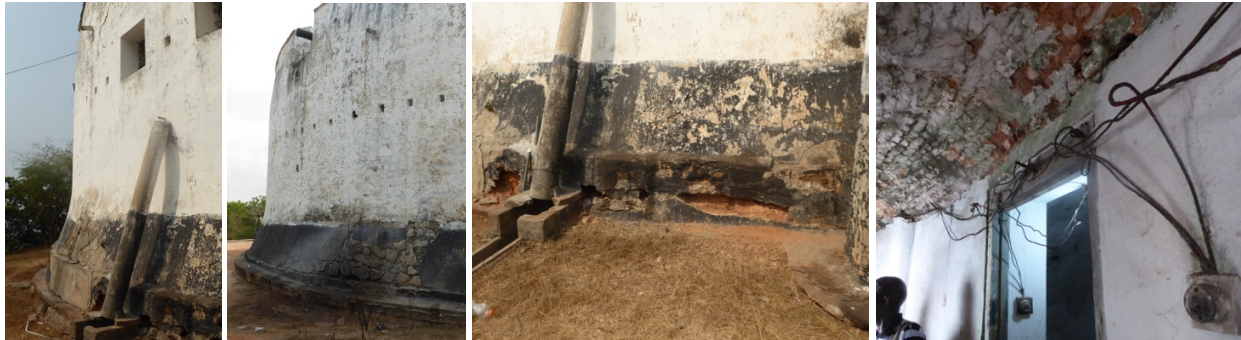
Figs. 139 to 142 – Problems resulting from water dropping at Fort William (Lighthouse) (figs.139 & 140); erosion on the basement of the exterior wall (fig.141); firebrick degradation on the basement vault and electrical unsecure wiring (fig.142).

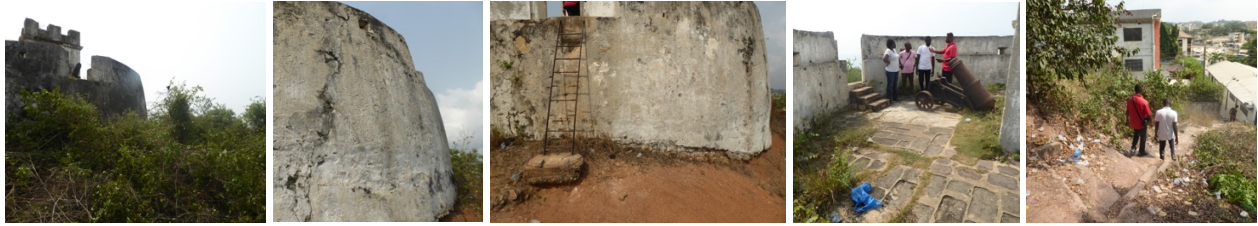
Figs. 143 to 147 – Fort Victoria is surrounded by bushes (fig.143), has some structural cracks (fig.144), foundations exposed and fragile metal stairs (fig.145), vegetation growing inside the fort (fig.146) and an unclear access to the fort (fig.147).

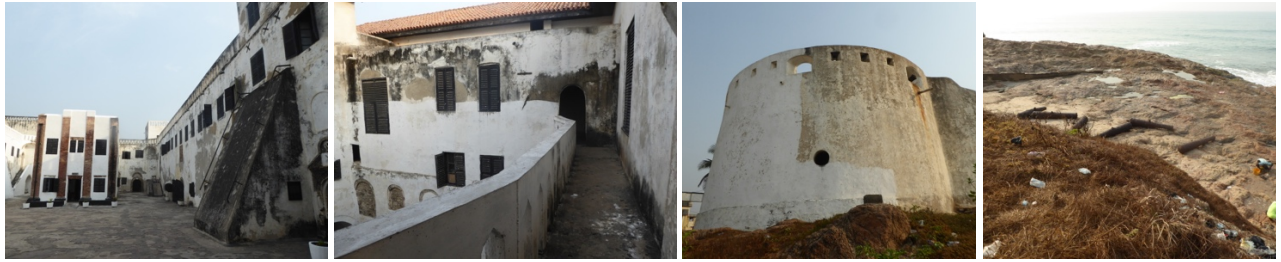
Figs. 148 to 151 – In St. George in Elmina, lack of maintenance is observed (fig.148), in spite of the partial lime-wash, which has not been concluded (figs.149 & 150). Cannons are also abandoned in the beach, in the surroundings of the castle (fig.151).

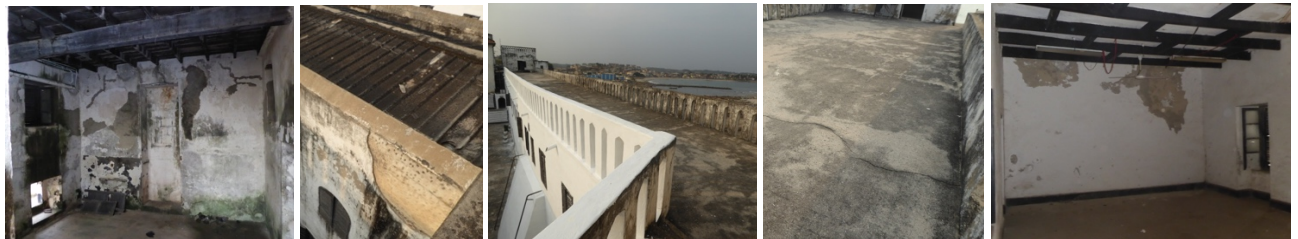
Figs. 152 to 156 – In St. George Castle in Elmina, lack of maintenance resulted in interior degradation (fig. 152); wall degradation (fig.153); terrace structural instability (figs.154 & 155), which caused unstable beams underneath the roof terrace (fig.156).

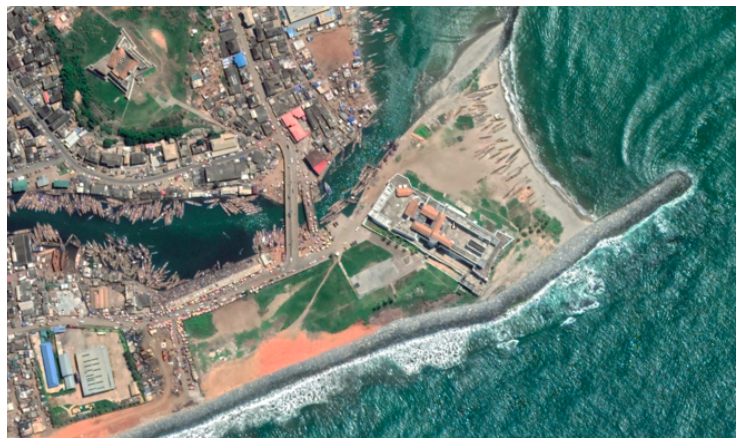
Fig.157 – Overview of St. George Castle in Elmina. View on a poster hanging on one of the walls at St. George Castle.

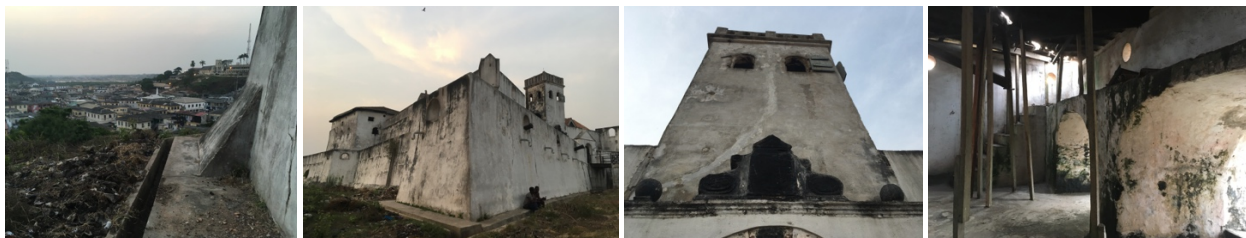
Figs. 158 to 161 – St. Jago in Elmina has several threats that are impacting the component

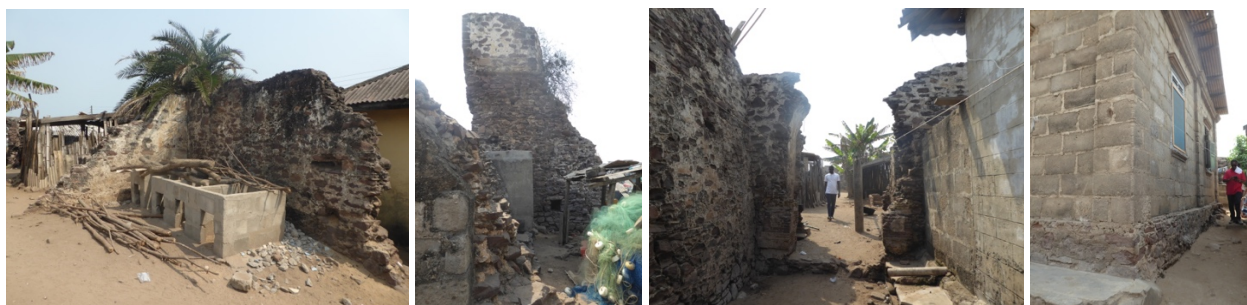
Figs. 162 to 165 – Abandonment, encroachment and urban pressure at Fort Vredenburg / Dutch Komenda.

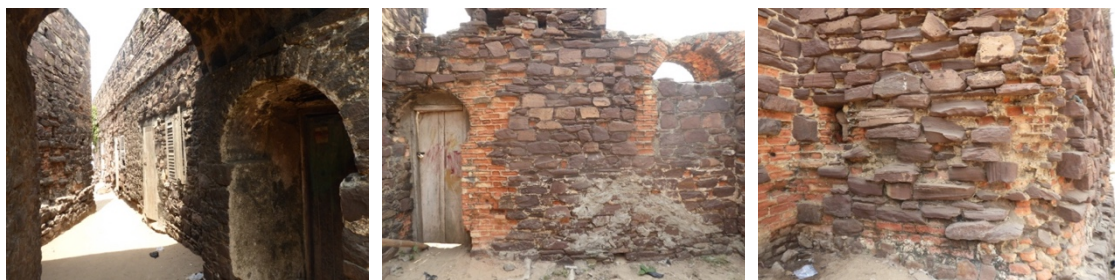
Figs. 166 to 168 – Some parts of Fort English are standing and are still in good condition (fig.166); however, other parts are facing high erosion especially regarding the exposed mortar from the stone masonry (figs. 167 & 168).

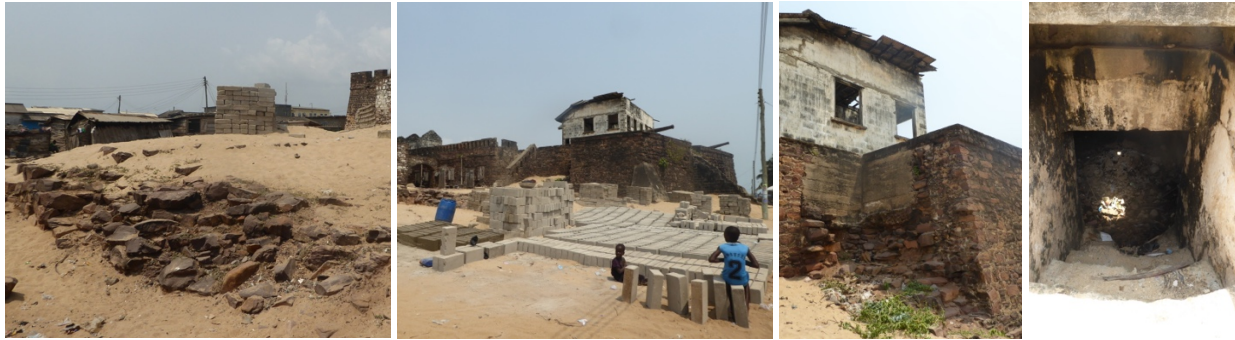
Figs. 169 to 172 – Encroachment is rising near the remains that are in ruins (fig.169); Material workshops occupy the open spaces (fig.170); new materials were introduced in the recent past (fig.171); some of the cave dudgeons are still open (fig.172).

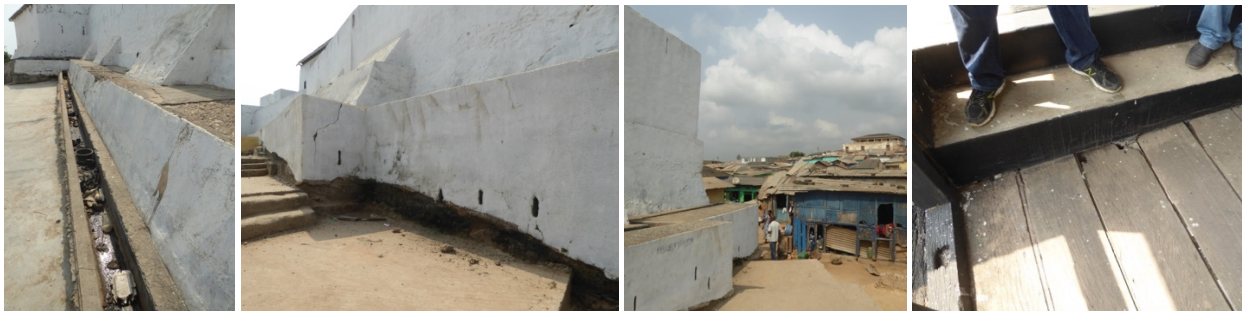
Figs. 173 to 176 – At Fort St. Sebastian gutters need to be cleaned (fig.173); some fort foundations are exposed (fig.174); there is some encroachment (fig. 175), and there is some wooden unstable pavement in the second floor of the fort (fig.176).

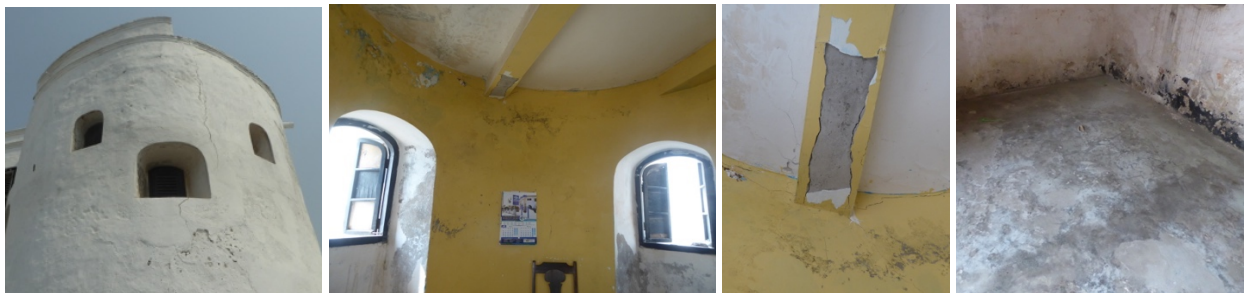
Figs. 177 to 180 – Concrete beams were inserted in the entrance tower which are not strong enough to hold the concrete 2nd floor.

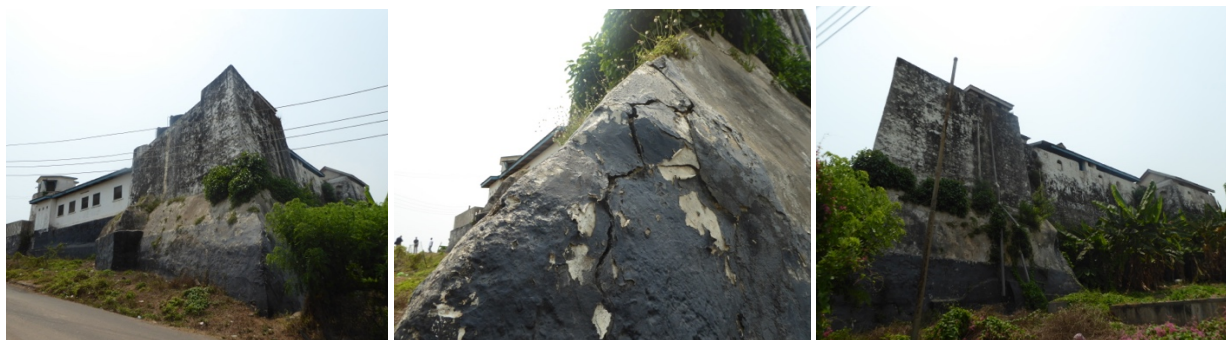
Figs. 181 to 183 – The rising of vegetation that is growing in the façades brought additional problems to the structure.

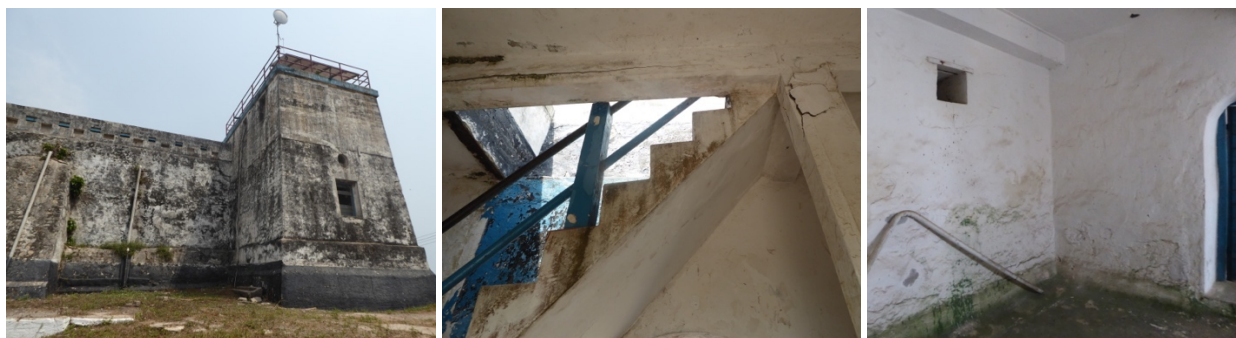
Figs. 184 to 186 – Fort Orange needs to have a better maintenance being regularly addressed (fig.184); especially as there are several problems with concrete beams in the interior of the fort (fig.185); there are new concrete ceiling interventions (fig.186).

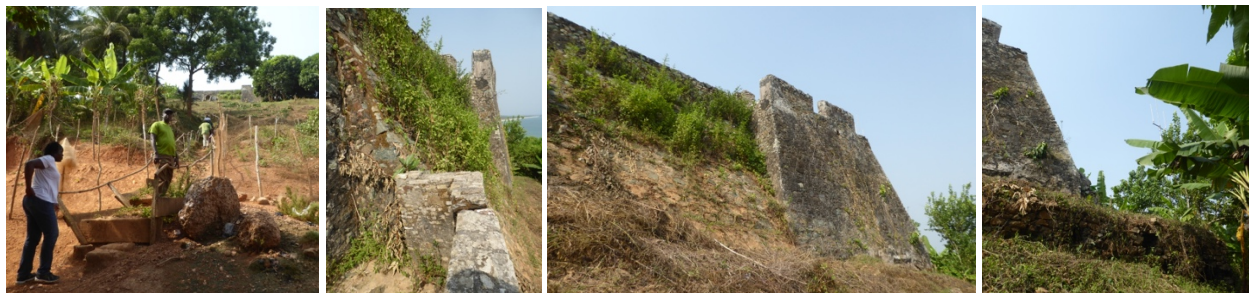
Figs. 187 to 190 – Access to Fort Batenstein is challenging and unstable (fig.187); the protective wall at the fort entrance is falling (fig.188); vegetation is growing in the fort walls (fig.189); and fort foundations are eroding in the south side (fig.190).
