**REPORT ON THE JOINT WORLD HERITAGE CENTRE / ICOMOS / ICCROM
REACTIVE MONITORING MISSION TO
FORTS AND CASTLES, VOLTA, GREATER ACCRA, CENTRAL AND WESTERN REGIONS
(GHANA)**

1 to 11 February 2020

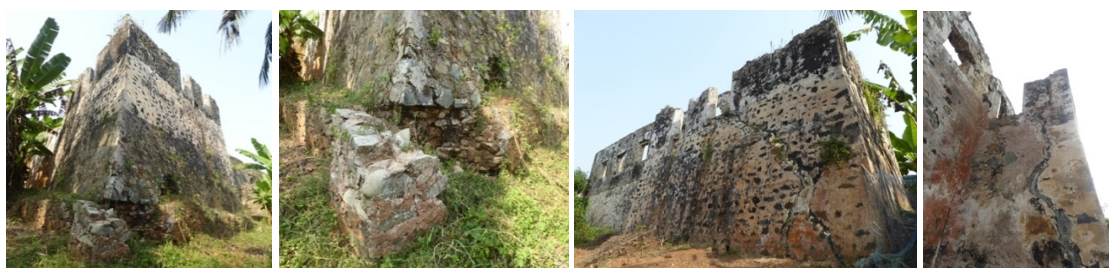
Figs. 191 to 194 – Several structural problems are potentially threatening Fort Batenstein stability.

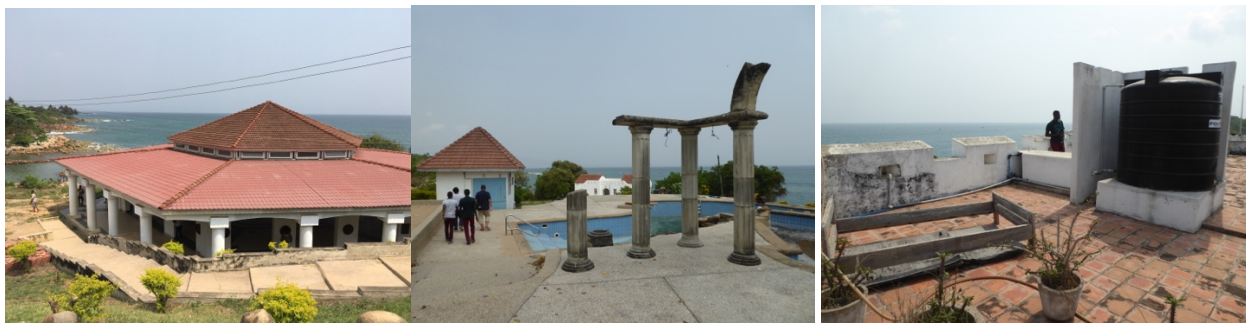
Figs. 195 to 197 – Restaurant, swimming pool, and roman columns built around Fort Metal Cross (Figs. 195 & 196); a bed, a bathtub, and a water tank were built for the tenant, on the terrace top of the fort, to have the ocean as a view (fig.197).

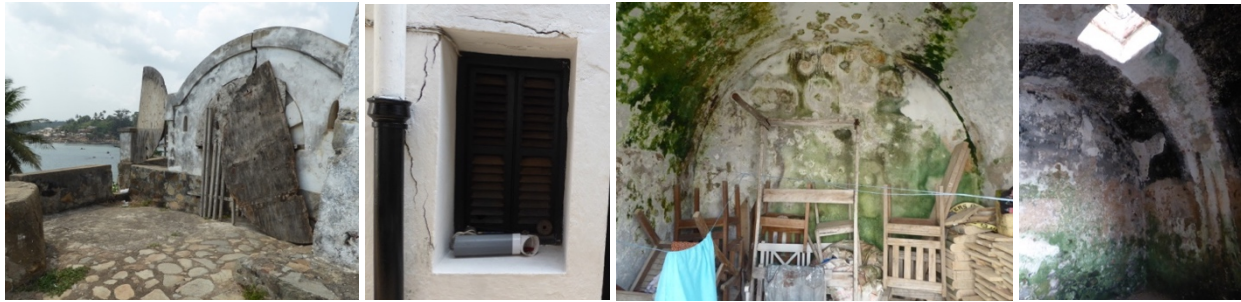
Figs. 198 to 201 – Structural problems at one of the entrances of Fort Metal Cross and at a new cement restoration (figs. 198 & 199); The slave dungeons are in bad state of conservation and are used nowadays as storage (figs. 200 & 201).

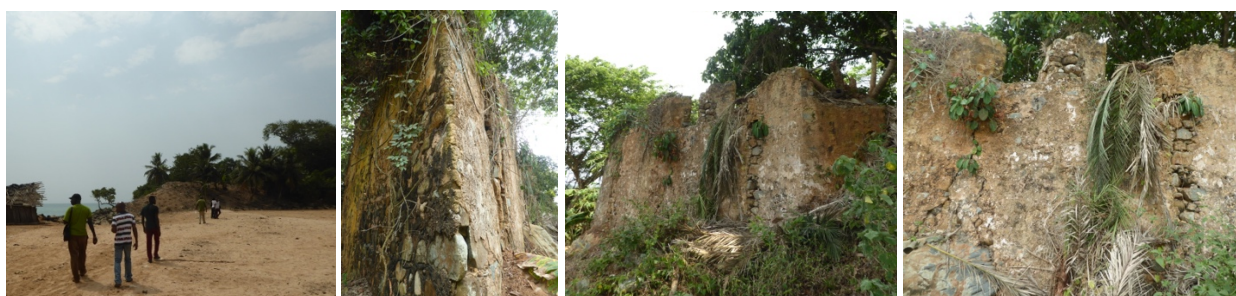
Figs. 202 to 205 – Access to Fort Dorothea (fig. 202); and structural problems emerging from root penetration (figs. 203 to 205).

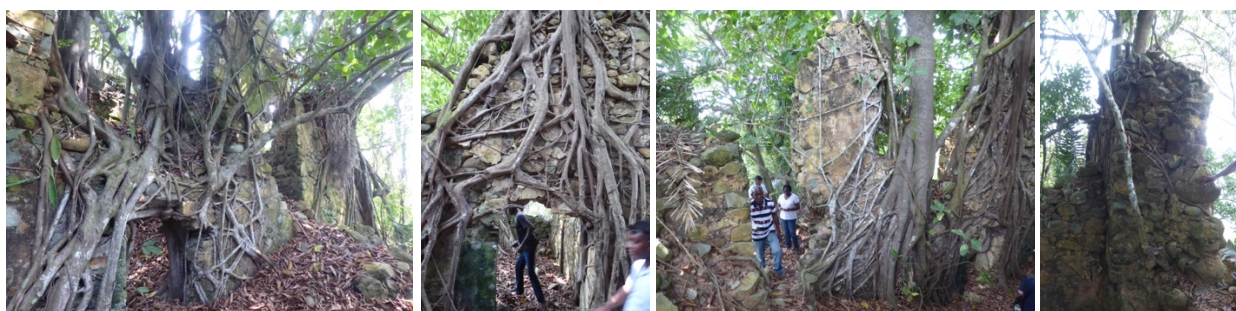
Figs. 206 to 209 – The remain ruins from Fort Dorothea are surrounded by tree roots.

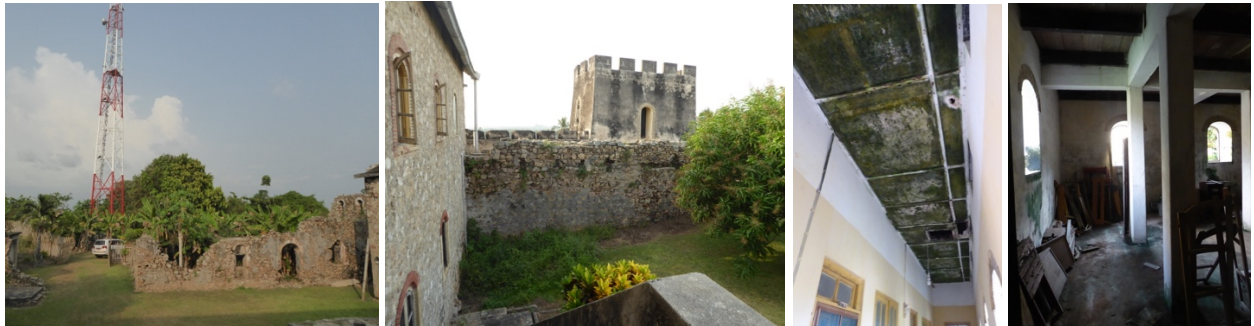
Figs. 210 to 213 – A high antenna lies at the entrance of Fort Groot Fredericksborg (fig.210); Humidity affects cement plaster (fig.211) and 2nd floor ceiling (fig.212); concrete structure was introduced in several parts of the buildings (fig.213).

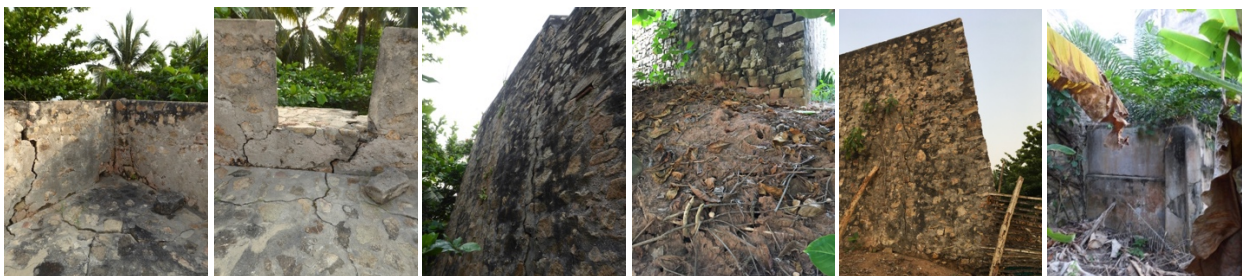
Figs. 214 to 219 – Structural problems are observed in the southern bastion (figs.214 to 216) and western bastion of Fort Groot Fredericksborg (fig.218). Termites are contributing to the soil settlement (fig.217). A shrine was built near the fort wall (fig.219).

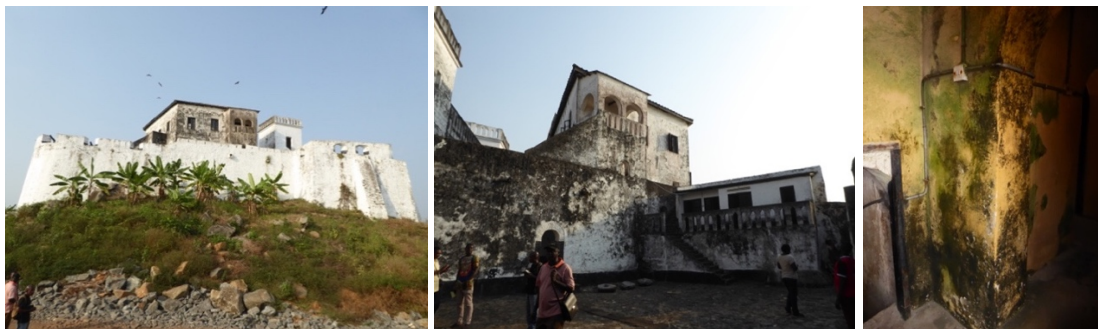
Figs. 220 to 222 – Lack of maintenance at Fort St. Anthony resulted in degradation of cement interventions and interior walls.

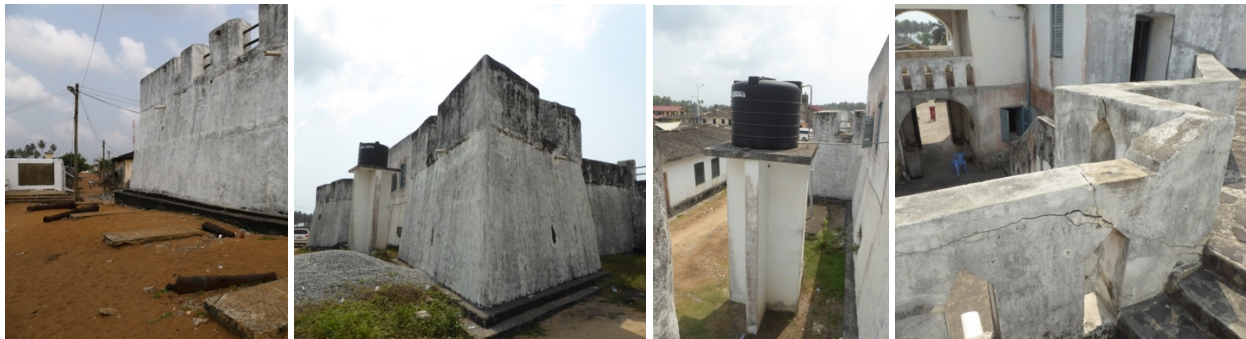
Figs. 223 to 226 – Abandoned cannons at For Apollonia (fig.223); Water storage jeopardises the fort's visual integrity (figs.224 & 225); structural instability of cement stair wall protection (fig.226).

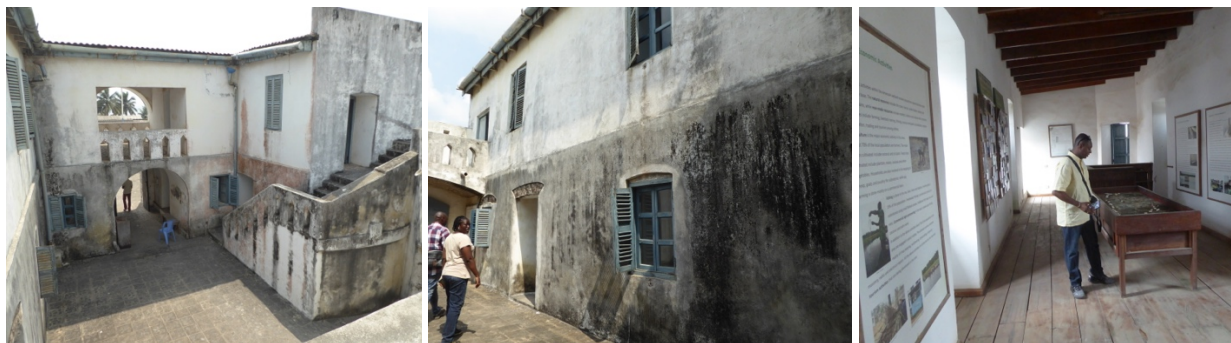
Figs. 227 to 229 – Lack of maintenance is observed in several walls (fig. 227 & 228); cement plaster intervention (fig. 228); and several interior exhibitions contribute for the community education and the fort interpretation (fig. 229), at Fort Apollonia.
