Article

20th-Century World Built Heritage Facing Water: Conservation of Fallingwater and Boa Nova Tea House

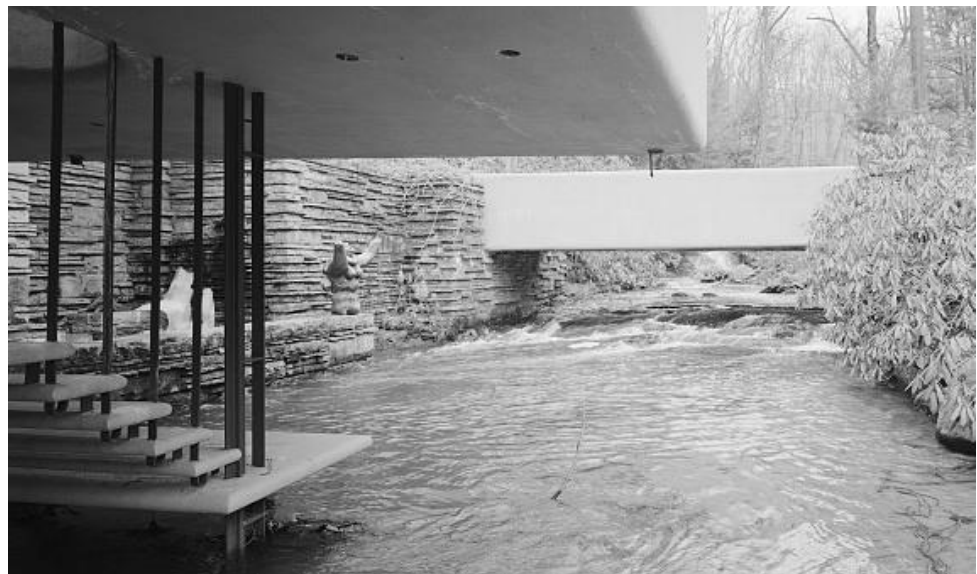
Figure 3. (a) Stairs of Fallingwater—view from southwest of steps and bridge over the stream. Reproduced with permission from Ref. [11]; (b) Kaufmann House, Fallingwater on Bear Run, Pennsylvania, 1935-1937, “plot plan” showing main floor bearing walls. Reproduced with permission from Ref. [12].

Bruno Zevi further contends that Fallingwater exemplifies the ultimate triumph over the constraints that have limited architecture for centuries. In this architectural masterpiece, the conventional "box" is entirely dismantled in a form of "four-dimensional decomposition" [8], where Wright prefigures and stimulates the objectives of Cubist exploration while also promoting the recognition and emergence of De Stijl poetics [8]. In Fallingwater, traditional walls, geometric patterns, symmetries, privileged perspectives, and rigid laws give way to principles of freedom and transformation [8]. Within this framework of freedom, Wright successfully incorporates material density and environmental *continuum* (Figure 3).

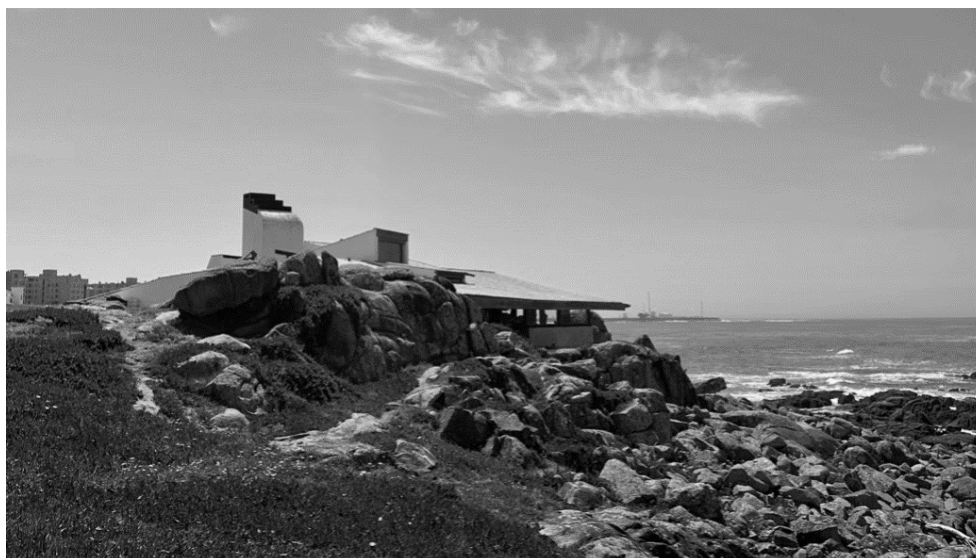
Figure 4. Tea House—North View—2023. Reproduced with permission from Susana Milão, Photo_CIAUD-UPT, author archive, 2023.
