Preventive Conservation of Vernacular Adobe Architecture at Seismic Risk: The Case Study of a World Heritage Historical City

Neda Haji Sadeghi, Hamed Azizi-Bondarabadi and Mariana Correia

Keywords: preventive conservation; vernacular; adobe heritage; earthen architecture; vaulted house; seismic safety; Yazd; cultural heritage preservation; HiStrA software Ver.2022.1.6

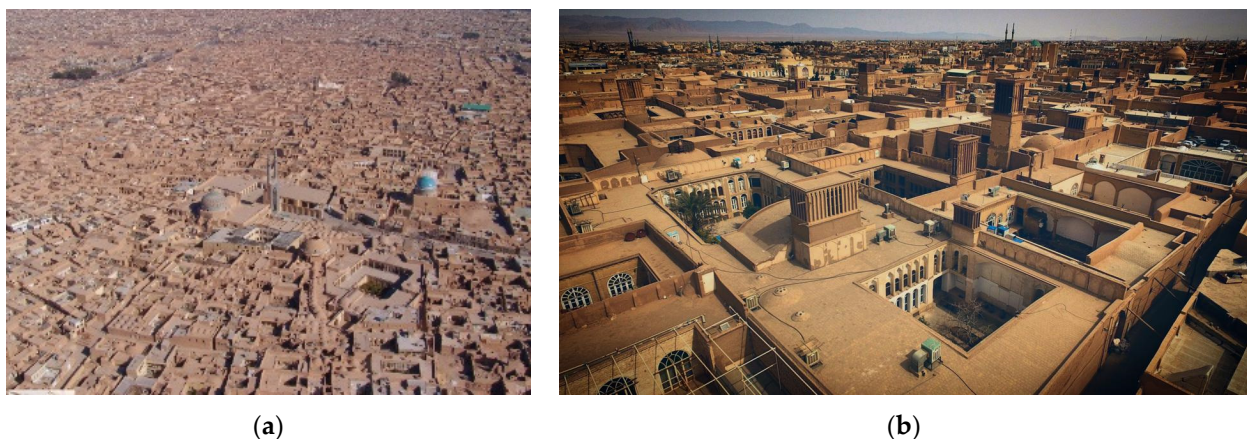
Figure 1. Yazd's historic fabric: (a) general view; (b) view of residential buildings (source: M. Hoseini).

The combination of these natural conditions, together with the local abundance of high-quality soil suitable for constructing adobe units, has established adobe architecture as the prevailing building style in the historic fabric of Yazd (see Figure 1). The well-preserved adobe architecture of Yazd includes religious buildings, palaces, defensive fortifications, gardens, schools, and traditional dwellings that originated from different historical periods after the Islamic Era, namely from the 6th and 7th centuries and thereafter.

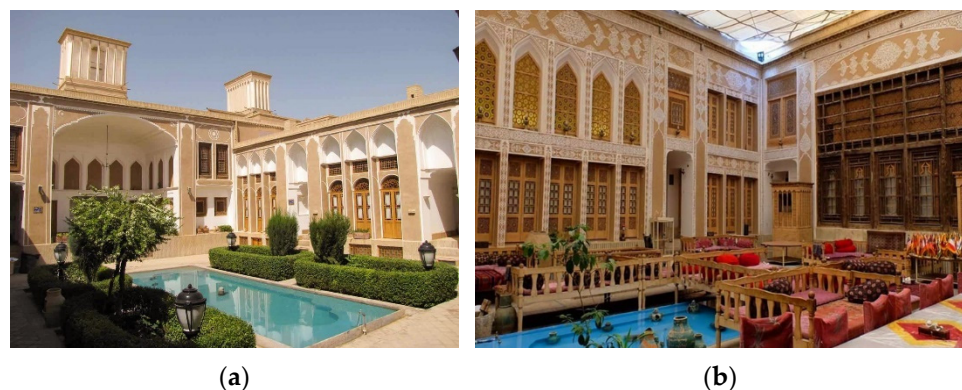
Figure 4. Distinguished adobe houses in Yazd historic fabric: (a) Golshan house (hotel–restaurant); (b) Malek-o-Tojjar house (hotel–restaurant) (source: N. Haji Sadeghi).

Significant conservation efforts in the city of Yazd have been carried out under the oversight of ICHTO (Iranian Cultural Heritage, Handcrafts and Tourism Organization), keeping alive the World Heritage city earthen fabric and preserving its cultural heritage. Public or private organizations or individuals rent or purchase the aforementioned buildings for a new purpose, such as offices, institutes, museums, hotels, restaurants, and schools (see Figure 4). Over the past several decades, there has been an increasing inclination to convert some impressive examples of architecture into conventional hotels and restaurants catering to both domestic and foreign visitors. Nevertheless, there is concern regarding the alteration of the identity of the houses when introducing new functions and activities.

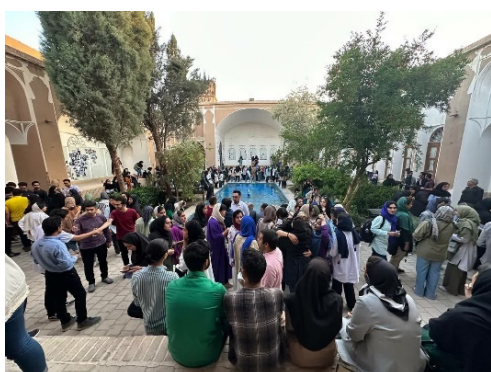
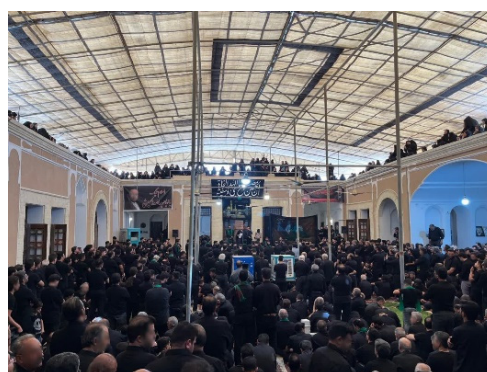
Figure 7. New function of adobe houses in the city historic fabric: (a) Art and Architecture Department at Rasoulian house; (b) Rismanian house (Source: N. Haji Sadeghi).

Preventive conservation interventions for vernacular adobe houses in Yazd must take into account the cultural, social, and historical value associated with these structures. Neglecting this value results in the erosion of people's identity and culture. The present and future functions of adobe buildings are critical for establishing seismic safety criteria. The majority of adobe structures within the historic fabric of Yazd have served as private residences. However, in recent decades, numerous adobe houses have been repurposed for various functions, including schools, institutes, hotels, and university departments (see Figures 4 and 7).

It is important to note that for many years, certain houses within the historic fabric of Yazd have hosted annual religious ceremonies on specific days. Most of these houses lack permanent residents, yet they attract hundreds of visitors on certain days (see Figure 7b). Consequently, prioritizing the preventive conservation of these buildings becomes essential. Furthermore, the classification of buildings in Eurocode 8 [57] and Standard 2800 [33] considers the social, cultural, and financial effects of building collapses.

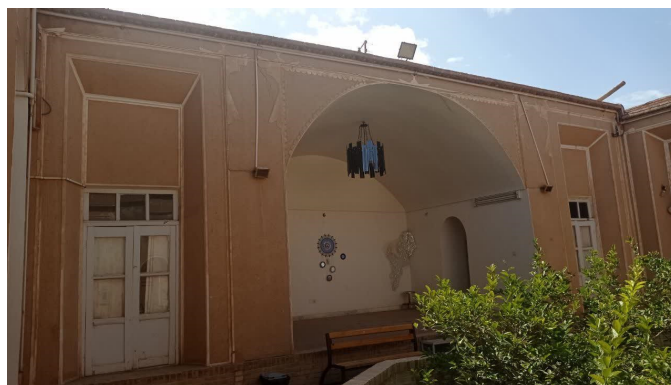
Figure 8. The adopted case study structure: (a) position in the Department of Art and Architecture, shown by a blue line; (b) the structure borderline, shown by a red line, and dimensions; (c) the structure exterior view.

This Talar space was chosen among several similar spaces in the department complex due to its simple form, consisting of a main central vault and two one-story adjacent smaller vaults (for more information about the Talar geometry types, see [88]), as well as its boundary conditions. The latter refers to the condition observed in the end section of the case study, which makes its numerical simulation possible without modeling the adjacent parts of the structure. As shown in Figure 8, the selected Talar space is surrounded by a dome and a perpendicular vault on the right and left sides, respectively. It was assumed that the existing dome and vault provide stiff boundary conditions on each side of the studied structure, as assumed in [88]. This can be simulated in the numerical model by considering supports at the end sections of the studied structure, namely on the exterior

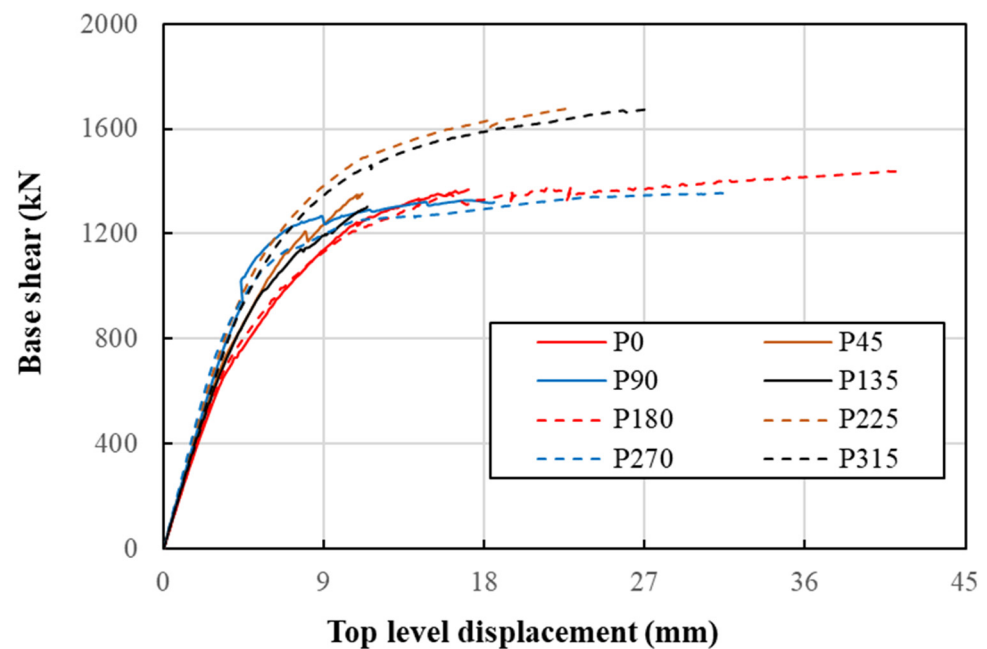
Figure 11. The pushover-obtained capacity curves of the unretrofitted structure in different analysis directions.

Figure 11 shows the capacity curves obtained from pushover analysis of the studied structure along different directions. The significant difference between the obtained capacity curves in terms of displacement and base shear force indicate the sensitivity of the structure's seismic behavior to the loading direction, arising from its irregular configuration and its lack of box-type behavior. This confirms the adoption of the MDPA method to govern the complex seismic response of the case study structure. Figure 12 depicts the results of analyses along the positive X and Y directions in terms of damage pattern. The

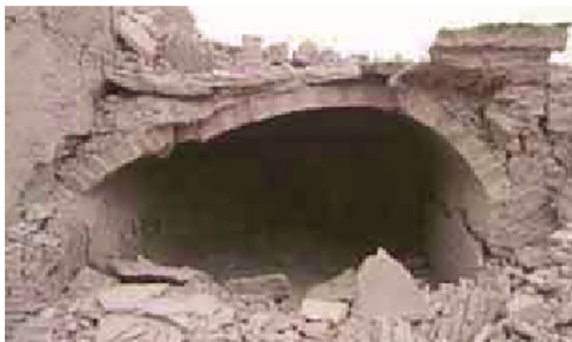
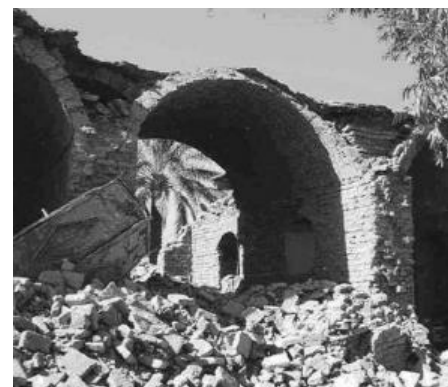
Figure 13. Real damage to adobe vaults during the 2003 Bam earthquake: (a) the in-plane failure mode and formation of plastic hinges [59] and (b) the out-of-plane failure mode and overturning of the vault's back walls [17].

formation of four plastic hinges in the vaults' transversal sections primarily governs the damage pattern in the X direction (Figure 12a). This implies that the in-plane action of the vaults is more effective than the out-of-plane action of the transversal walls (the walls along the Y direction) in resisting the X direction's imposing loads. The vault span has two hinges on each side, with additional hinges located at the vault's imposts. This failure mode is common for vaulted structures under asymmetric lateral loading. In the Y direction, the out-of-plane overturning of the longitudinal back wall due to insufficient connections between the wall and vaults is predominant (Figure 12b). The failure modes in both directions have been observed during past earthquakes—in particular, the 2003 earthquake that occurred in the city of Bam, characterized by its adobe vaulted buildings (Figure 13) (for more information, see [108]).

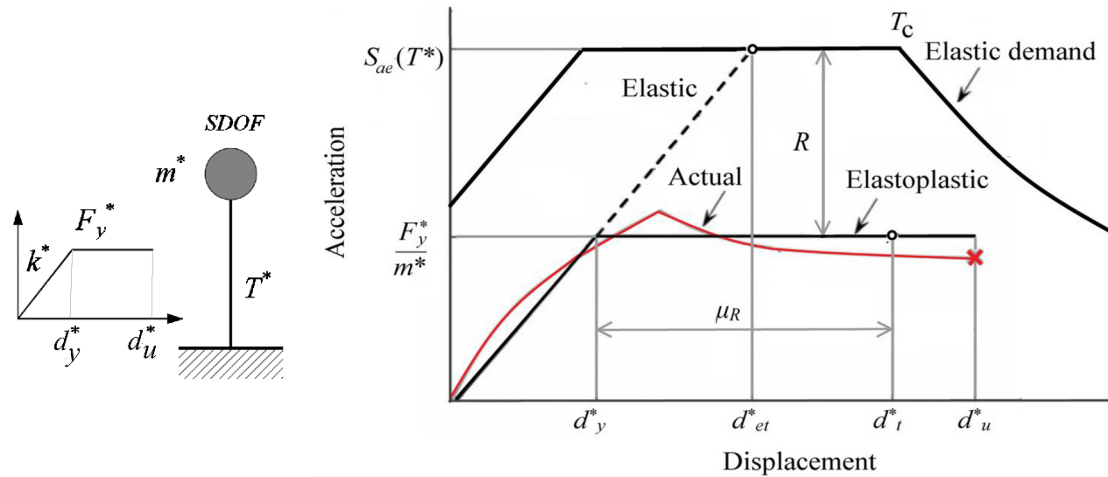
Figure 14. The procedure of the N2 method to determine the target displacement of short-period structures (adapted from [128]) (the red curve represents the actual capacity curve of a SDOF structure).

where T^* is the period of the equivalent SDOF system, which can be obtained using the system's yield shear force (F^*_y) as $T^* = 2\pi \sqrt{\frac{m^* d^*_y}{F^*_y}}$. Table 4 presents the results of the N2 method applied to the studied structure. In Table 4, d_t is the target displacement of the MDOF structure obtained as $d_t = \Gamma \cdot d^*_t$.
