Correia, M., & Guerrero, L. (2018). Conservation of Earthen Building Materials. The Encyclopedia of Archaeological Sciences, 1-6. <https://doi.org/10.1002/9781119188230.saseas0117>

Conservation of Earthen Building Materials

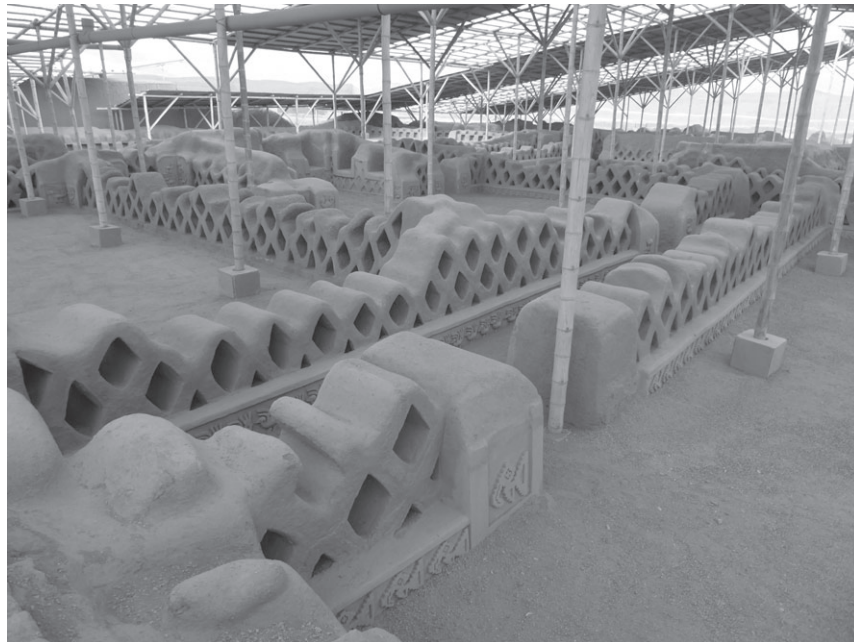
Figure 1 Chan Chan is an earthen endangered archaeological site classified as World Heritage, in Trujillo, Peru.

A less radical measure is the designing and placement of *protective shelters*. This measure has been proven effective for several decades in some cases, and ineffective in others due to wind dynamics. It has the advantage of favoring public visit to the sites, while protecting the site from possible damage caused by rain, wind, snow, or hail. However, any change in the temperature and humidity of the earthen structures sets their material integrity at risk, as much of their stability is derived from the equilibrium they possess with the amount of water they contain. An excessively humid earthen structure can disintegrate, but the same happens if the earthen structure is too dry, as it loses cohesion. As a result, when choosing shelters to cover earthen sites, the main aim should be the hygrothermal balance of the interior spaces. Shelters can also dramatically alter the visual relation of the archaeological sites. Therefore, their form, height, and materials must be carefully and sensibly designed (Figure 1).

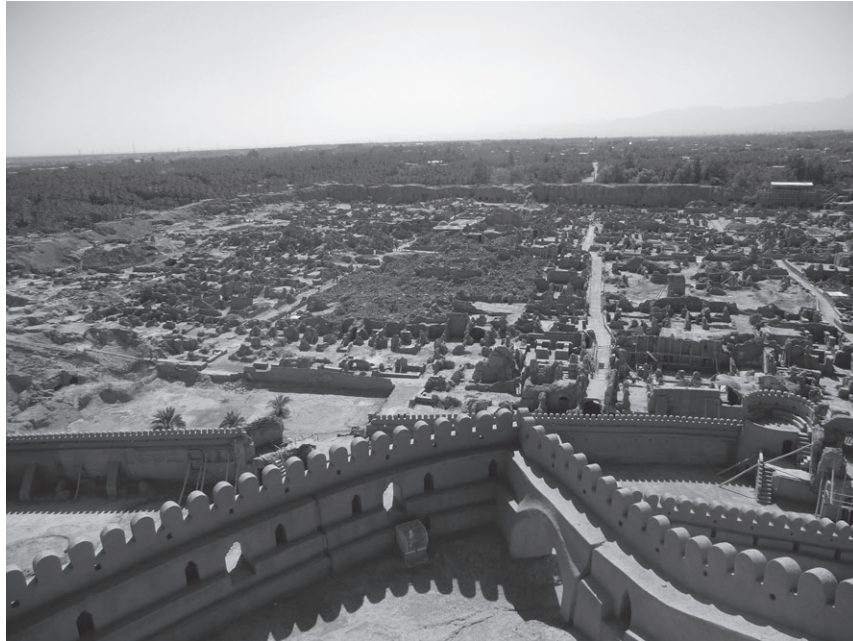
Figure 2 Arg-e Bam is an earthen citadel classified as World Heritage, in Bam, Iran.
Source: Photo by Mariana Correia, October 2011.

The use of geotextile membranes to protect the earthen structure before applying the surface coating can also be considered. These are often used on the reburial of excavated structures, as previously mentioned. They are useful because once covered with sacrificial coatings, they allow the natural flow of water vapor in the structures, generate a surface protection barrier, and can be removed when required. However, the membrane selection and application and its earthen coating should be addressed carefully. It often happens that, upon application, the elements and components of the site that were covered are no longer recognized, and the architectural value of the component is lost (Figure 2).
