# The Impact of Pollution on Cultural Heritage in the Historic Centre of Porto, Portugal

Fátima Matos Silva, Marta Arreiol and Ana Fragata

<https://doi.org/10.3390/urbansci8020031>

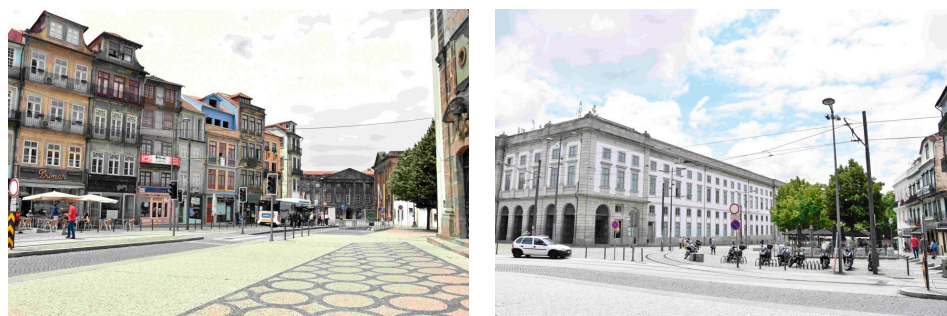
**Figure 9.** View of Carmo and Carlos Alberto Square, Porto. Source: Author.

The high level of car traffic in this area may explain the degradation of the granite stone and tiles that cover the façade. As there are no buildings or vegetation to protect the façade, it is more susceptible to external agents, such as rainwater and the water–wind combination.
